# Quality and Reliability Investigation of Printed Circuit Board Micro-Vias by X-ray Inspection

By David Bernard and Bob Willis

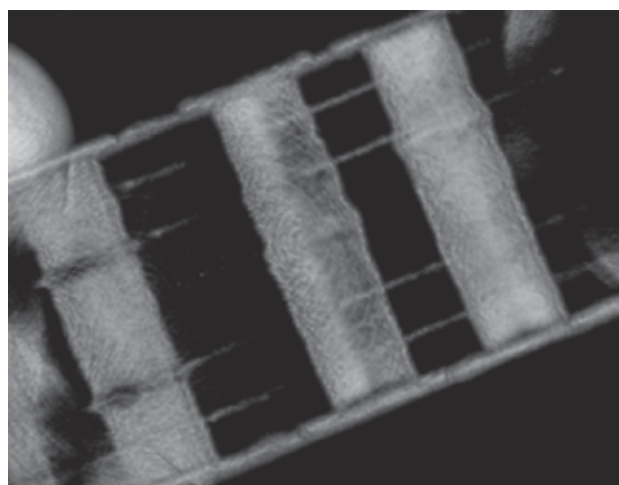
Image 2: 3D CT model image of micro-vias

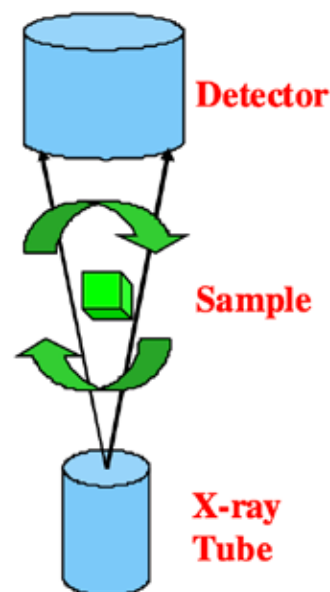
Diagram 1: Rotation of the sample perpendicular to the tube/detector axis is required for CT functionality. Images (projections) are taken at every step in the rotation.

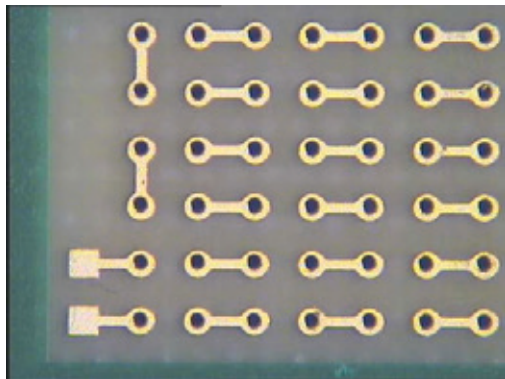
Image 4: Optical image of 200µm diameter micro-vias used in the test vehicle.

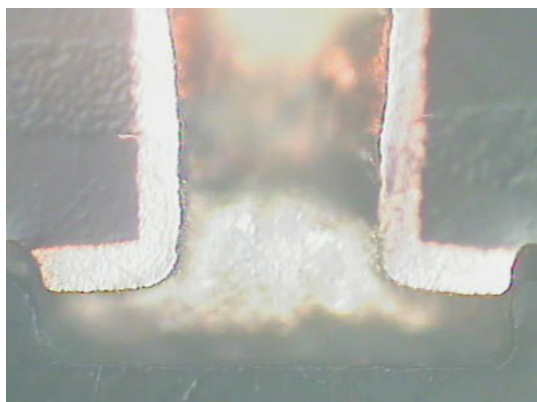
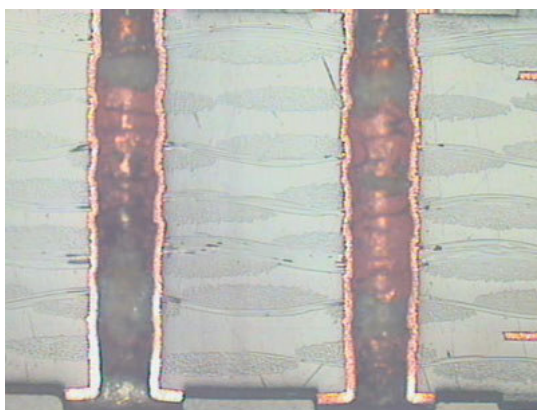
Images 6 and 7: Micro-sections of selected 0.2mm (0.008") holes after testing of OSP board

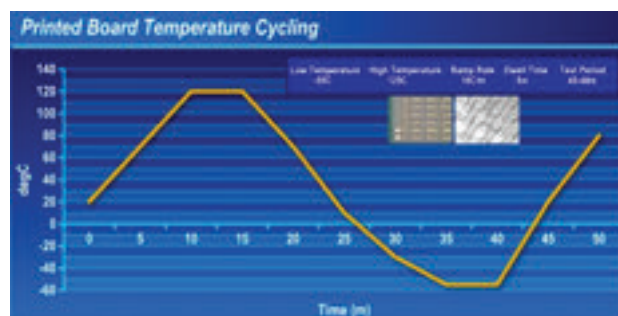
Image 8: Thermal cycling regime used on the test boards at the UK National Physical Laboratory

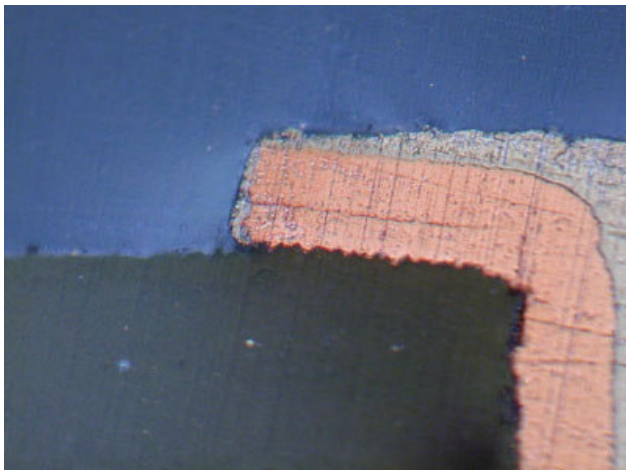
Image 13: Evidence of pad lifting caused by repeated expansion in the z-axis

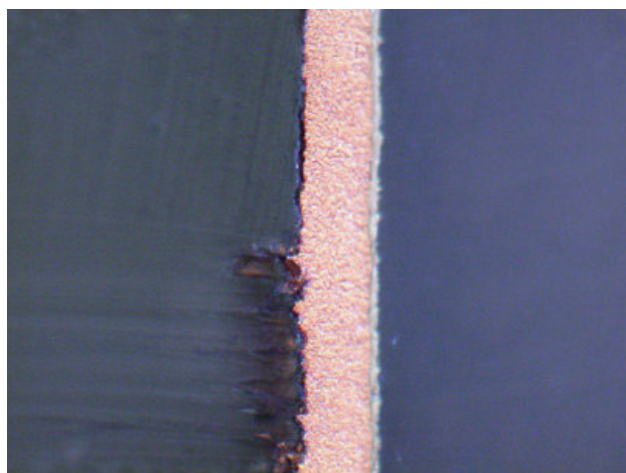
Image 14: Minor evidence of the copper plating pulling away from the hole wall. This is not uncommon on new high Tg laminates even without processing.

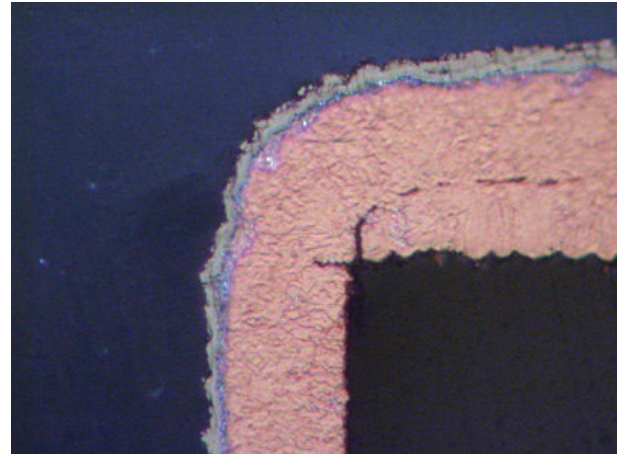
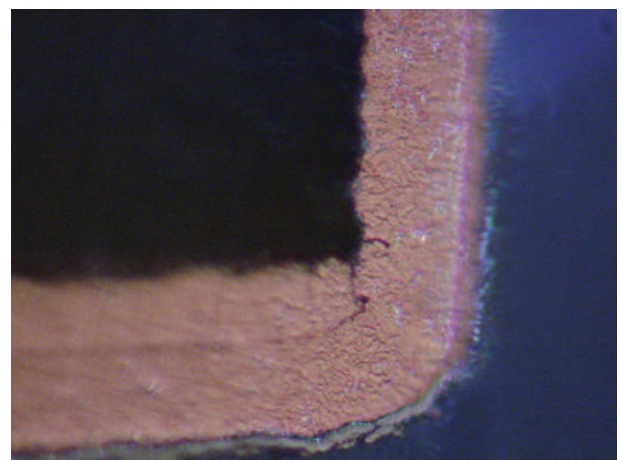
Images 15 – 18 below show minor copper cracking in the through-hole plating. In each of the examples, the copper is cracking in-line with the copper foil – as shown by the red circle. Normally in thermal shock testing, the cracking would be seen at the knee of the hole.

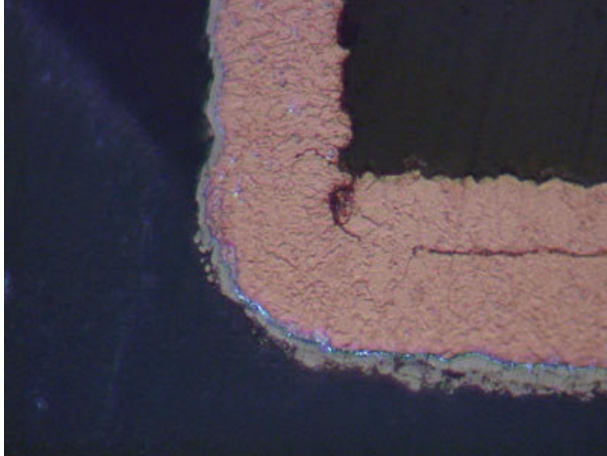
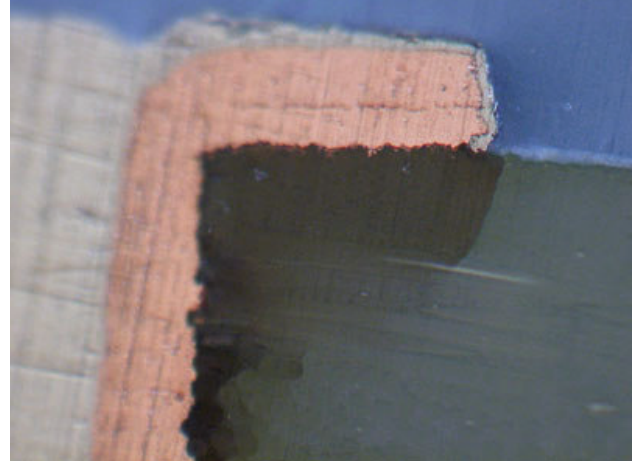
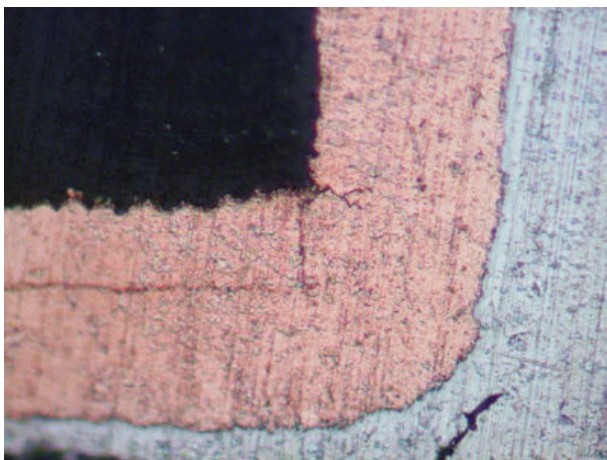
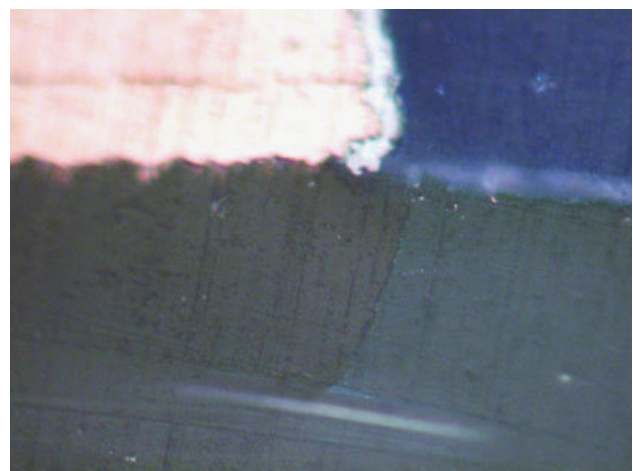
Images 19 and 20 below show two examples of laminate cracking that were observed during examination of the samples – as shown by the arrow location. This is often seen with high Tg laminate materials during mechanical testing after just one reflow operation due to the hardness of the resin.

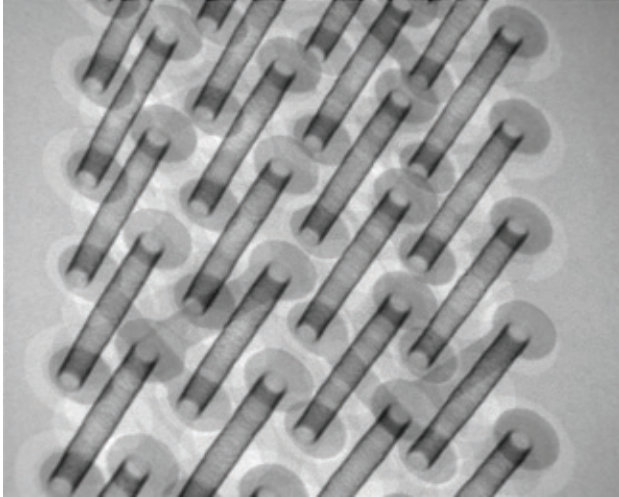
Image 21: 2D X-ray image at oblique angle view of NPL Studio Project micro-vias in a failed and visibly delaminated board

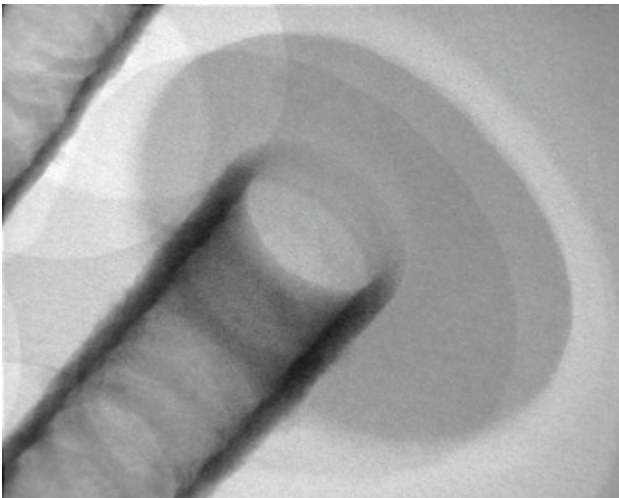
Image 22: High magnification 2D x-ray image at oblique view of part of a micro-via within a failed but visibly un-delaminated NPL board

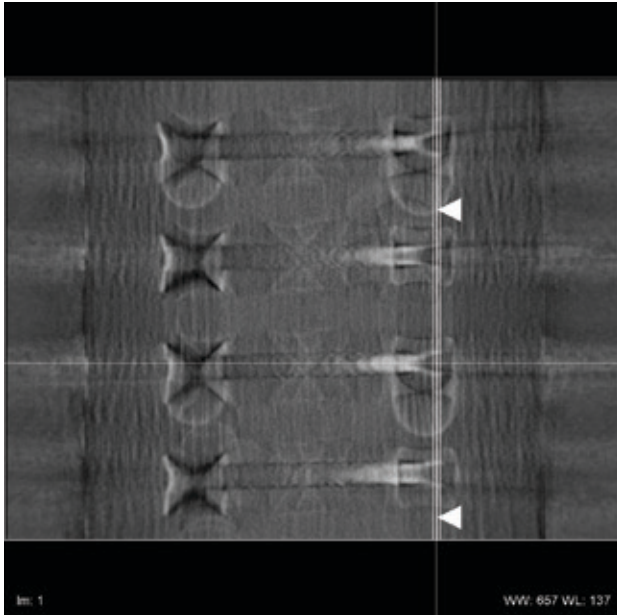
Image 24: 2D view from the CT reconstruction indicating the location relative to the micro-via depth of the cross-sectional slice shown in image 24 (between the white vertical lines).
