Correlating the Presence of Popcorned BGA Devices Post Reflow With Solder-Ball Diameter Measurements From X-Ray Inspection

By David Bernard and Bob Willis

Abstract

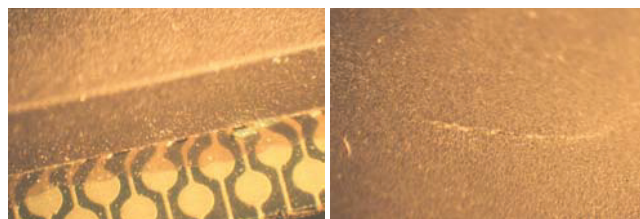
Instead, the most common method of identifying that popcorning has occurred is to look at the device solder joints. This is because as the package swells, great forces will be applied to the package joints. With QFP package types, for example, then the gull-wing leads may move or re-align / misalign during the liquidus phase because of the package distortion. An intermittent failure mode may also be possible for QFPs at the package / board joints because, like the internal wire bonds discussed earlier, these joints may have lifted out of the paste when in the liquidus state but after reflow still be in physical contact with the pad. So as the package warms up during use further package distortion can occur and so create an open joint. These situations may well be seen optically for a QFP. However, such situations cannot be observed optically for a BGA, where the solder balls are all hidden under the device, and so x-ray inspection becomes vital for the analysis. Optically, there may be cracks seen in the package molding and for QFPs, it is also possible for cracking to occur along the line of the lead frame. Seeing these cracks optically is not always easy, however (see image 0).

Image 0: Left image - side shot of BGA with crack between the plastic cover and the BGA substrate. Right image - crack on top surface of plastic BGA.

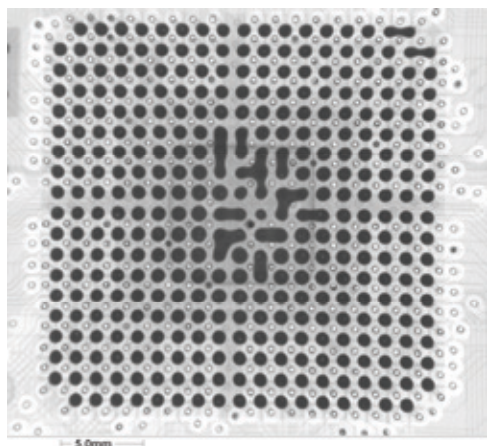
Image 1: Bridges seen in x-ray image under BGA following device popcorning.

The popcorning of BGAs is often indicated by the presence of bridging under the device. This is caused when the expansion of the package during reflow causes it to ‘dish’, where the underneath of the package deforms and presses down onto the solder balls underneath. As the solder is liquid at the time, it allows the solder from adjacent balls to coalesce and so produce bridges. These are very clearly seen in the x-ray image (see image1).

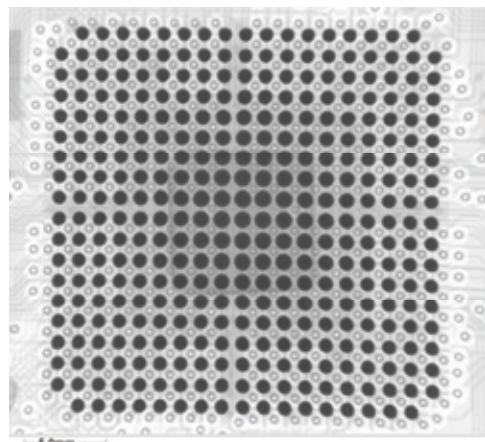
Whilst bridging between solder balls is a very common indicator of a popcorned BGA, it is possible that bridging does not always occur. In such cases there will still be evidence of the package deformation because the ball diameters across the BGA will not be consistent. Instead, solder balls at the centre of the package would be expected to be larger in diameter (where they have been pressed down), with the other solder ball reduced in size as the edges of the package have been lifted. Such a situation can be seen in image 2.

Image 2: X-ray image of a popcorned BGA, where the central solder balls are much greater in diameter than the outer solder balls but bridges have not formed.

This analysis can be confirmed through an investigation of the solder balls at oblique angle views in the x-ray system. Where there reflow is good then there is a consistency of the solder joints with a typical shape seen in image 3. In contrast, the central solder balls of image 2 when seen at an oblique angle look as shown in image 4. Although there is no bridging in image 2, the difference in solder ball diameter between the inner and outer solder balls is very clear. So this solder ball diameter variation is sufficient to flag this device for at least further investigation, or, more likely, replacement. Therefore measuring and comparing the BGA solder ball diameters offers the opportunity to identify popcorning even if the most obvious signs (bridges) are not present in the x-ray images.

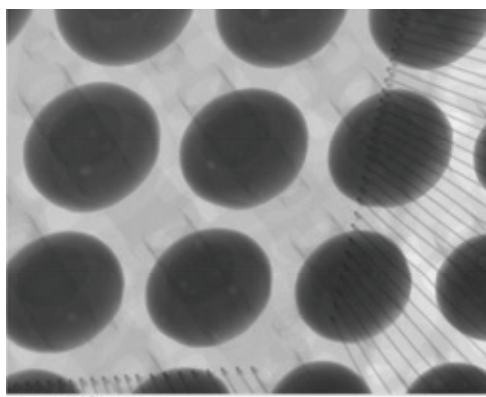
Image 4: Typical x-ray image of popcorned solder balls such as those seen under the centre of the BGA device in image 2.

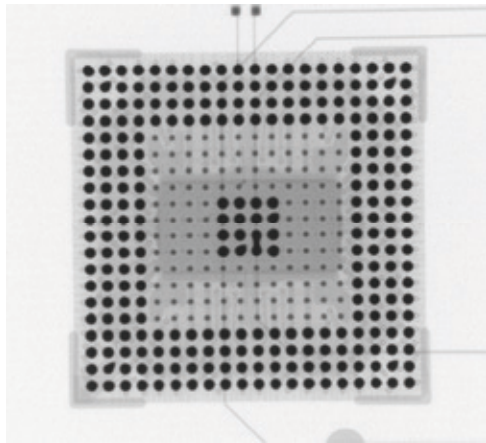
The success of (mal)-treating the BGAs prior to reflow resulted in all of the BGAs exhibiting some bridging under the central part of the BGA, irrespective of board finish and reflow method used. These bridges can be clearly seen in the x-ray image (see image 6) and this observation would be sufficient on its own to demand re-work and replacement of the BGA.

Image 6: X-ray image of BGA on gold finish board (designated Gold 7) following convection reflow. A bridge under the central part of the device is clearly seen.

Apart from the obvious bridge, variation of the solder ball diameters between the inner and outer balls is not that obvious compared to image 2. To check the ball diameters, the system software looks at the BGA under higher magnification than that shown in image 6, so that the BGA is split into a number of smaller areas. The operator can trade-off the magnification used for the analysis against the speed of throughput. In other words, using higher magnification for the analysis area within the BGA provides fewer solder balls on screen but each solder ball has a relatively high number of pixels, so enhancing measurement precision. However, many more analysis areas within the BGA must be inspected at this higher magnification. So a trade-off was made through the simple software interface to balance good precision against overall speed of inspection.

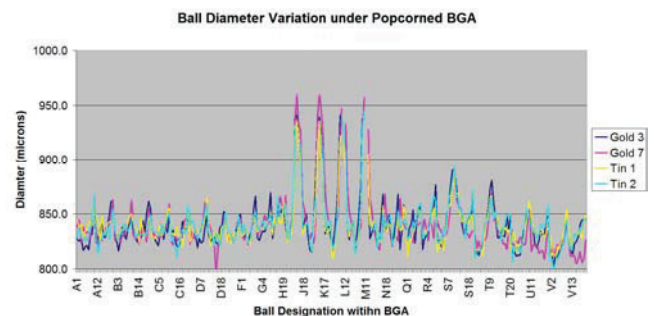
Figure 1: Normalised solder ball diameter measurements.

Figure 1 clearly shows a marked difference in the measured solder ball diameters between the central solder balls and those on the outside. This can be shown more clearly in figure 2, where the

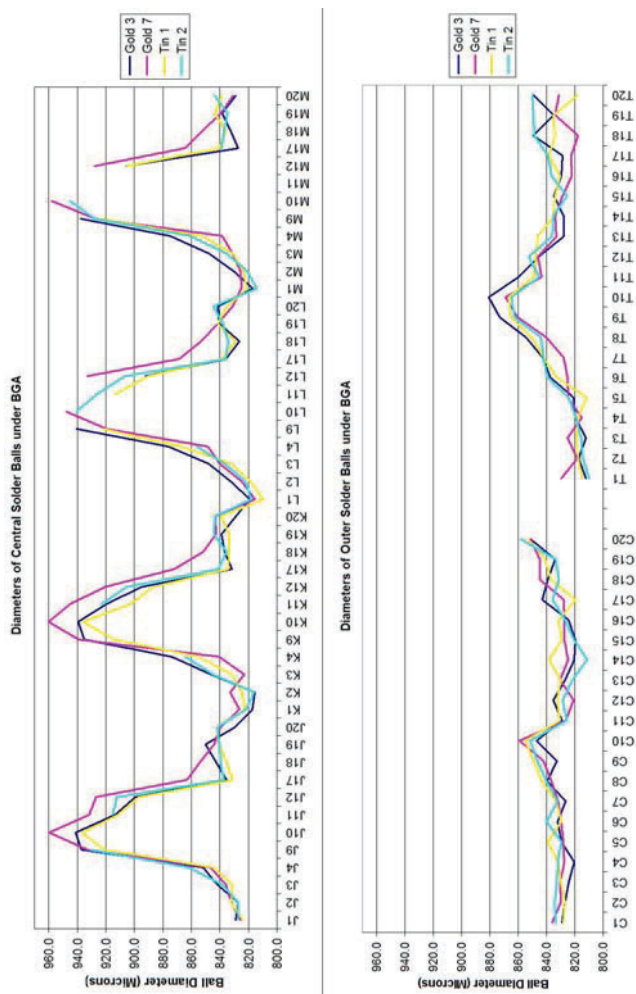
Looking at the data more closely, the average ball diameter for all of the measurements under the central area is $\sim 925 \mu\text{m}$. In contrast, the average ball diameter size in rows C and T of the device is $\sim 835 \mu\text{m}$. In other words, there is an approximate increase of around 11% in the central solder ball diameter compared to the outer balls. Such a diameter difference in percentage terms is large but, as can be seen from image 6, at low magnification this difference would not necessarily be obvious to an operator. Of course, the operator would immediately see the bridge in this example. However, if the bridge was not present then the escape of a clearly faulty board could occur if BGA measurements had not been taken.

Figure 2: Central solder ball diameters compared to outer row solder ball diameters under the same scale. Gaps in the data lines are locations of bridges seen under the devices.

It is suggested that a variation of more than 7% in the solder ball diameter compared to the average would strongly indicate that a problem may exist. This method will be more reliable than just looking to try and see delamination or die cracks manually within an x-ray image because of the lack of available density variation in the image owing to the additional densities present of board material and packaging. This approach also means that there is no need to consider immersing the board into water for scanning acoustic microscopic analysis, for example.
