The Last Will and Testament of the BGA Void

By Dave Hillman, Dave Adams, Tim Pearson, Brad Williams, Brittany Petrick, Ross Wilcoxon Rockwell Collins, Dr. David Bernard, John Travis, Dr. Evstatin Krastev, Vineeth Bastin

Abstract

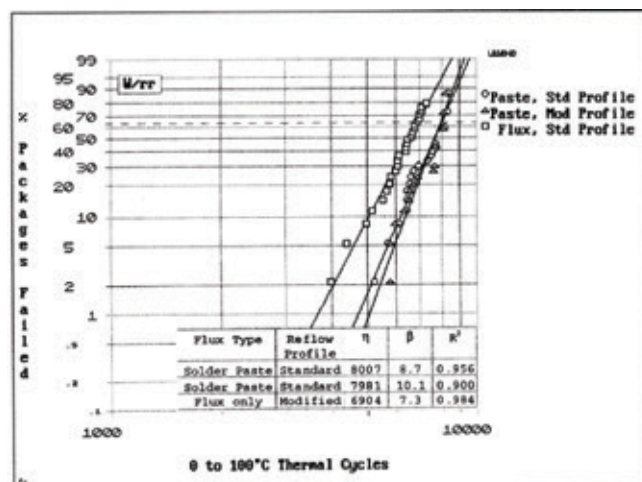
Figure 2. Failure Data Weibull Plot from Banks [5]

Figure 2 illustrates Weibull plots that show that BGAs with voids (i.e. Mod Profile) and BGAs without voids (i.e. Standard Profile) did not have distinguishable solder joint failure populations. Banks' work was one of the earliest published tin/lead solder alloy investigations to demonstrate that macro voids did not interact with the solder joint failure cracks and their presence did not cause solder joint failure.

- Typical void size was 2-3% diameter, overall range was 0-24% diameter
- Voids were typically found at solder joint / BGA package interface
- Voids did not appear to alter crack propagation path
- Voids had no effect on solder joint integrity (Figure 2)

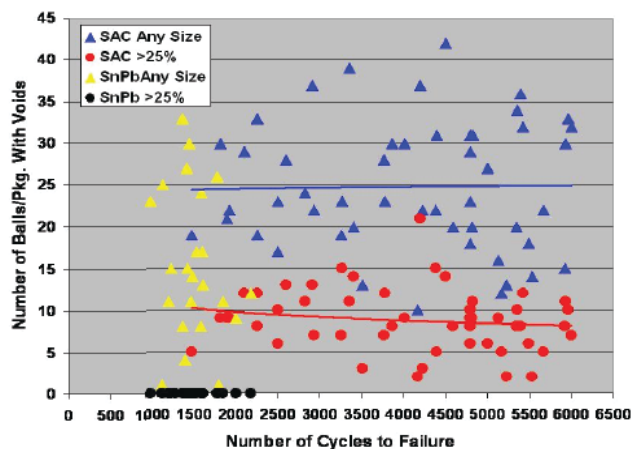
Figure 3. Solder Joint Voiding Versus Cycles to Failure for CSP84 Component [6]

The SPVC investigation demonstrated that the number of cycles to failure did not correlate with void size. If there was a negative influence of voids on the solder joint integrity, Figure 3 would show a cluster of early low cycle failures for larger voids and a cluster of late cycle failures for the small voids. This was not the case; the results show a uniform data spread for the number of cycles to failure for both void size populations, with no distinctly different groups for either the tin/lead or lead-free solder alloys.

- Both test vehicles had voiding greater than 25% of the X-ray image area in multiple components
- SAC solder had more voids than SnPb solder
- No correlation was found between void size and solder joint integrity (Figure 3)

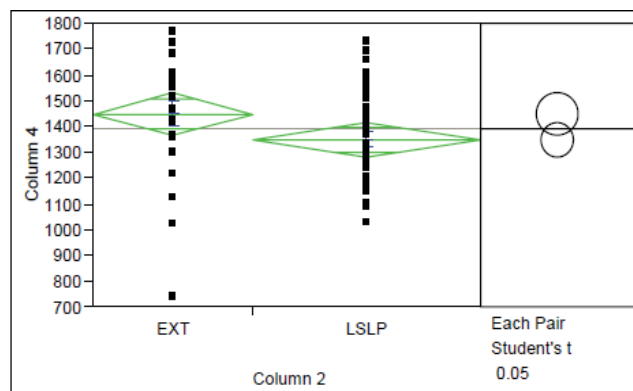
Kim’s investigation utilized two different reflow profiles – typical (aka LSLP) and non-typical (aka Extreme) – to generate voids in the BGA solder joints. The LSLP reflow profile produced minimal voiding whereas the Extreme reflow profile resulted in voiding as large as 60% of the solderball diameter. Preconditioning of the BGAs prior to reflow (10 days of 60°C/60%RH) was included in the test as an additional technique for generating voids. Analysis of the thermal cycle results revealed that there was no statistically significant difference between the void and void-less solder joint populations for the 144 I/O BGA components (Figure 4).

Figure 4. Statistical T-Test for Solder Joint Voiding Showing Indistinguishable Failure Populations [7]

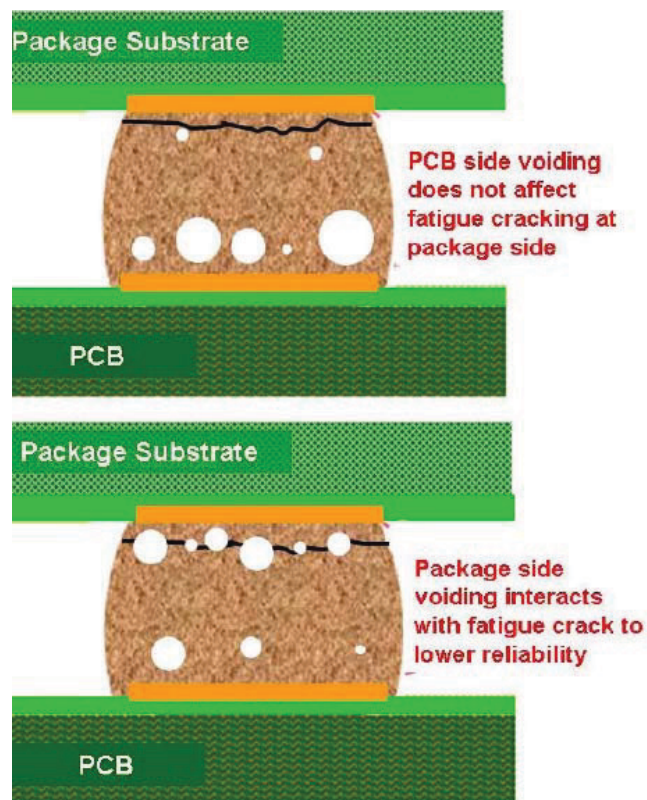
Figure 6. Impact of Voids on Solder Joint Integrity, D. Coyle et al [9]

The Coyle investigation found that macro voids reduce solder joint reliability by reducing the effective attachment area and that this geometric effect was independent of solder alloy composition. The study concluded that the dominant factor that impacts solder joint integrity was void location and not the void size or density of voids.

- Overall void density on BGA component was not high
- Solder crack path typically found at solder joint / BGA package interface
- Planar (flat) metallographic cross-sectioning thru package/ solder joint interface showed a high incidence of voiding not observed in orthogonal cross-section
- Solder voiding had a negative impact on solder joint reliability only when void density was high and void location was in the crack path (Figure 6)

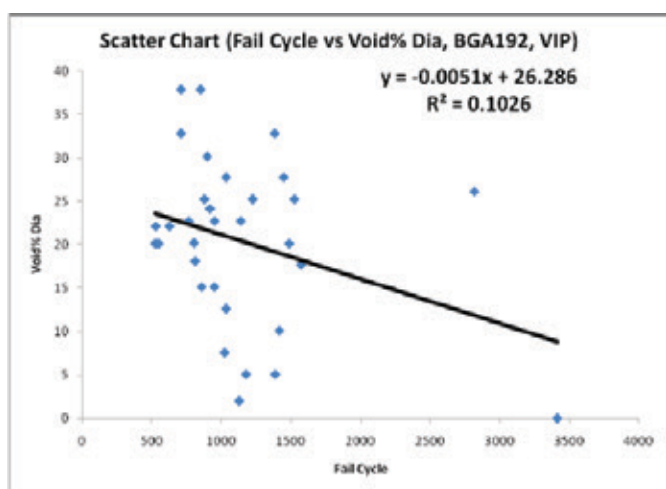
Figure 7. Scatter Chart Showing No Correlation between Solder Joint Void and Thermal Cycle Integrity, J. Smetana et al [10]

The Smetana investigation documented that for both a ceramic BGA component and a plastic CSP component, the void diameter or area percentage had no correlation to solder joint thermal cycle integrity. Cross-sectional analysis revealed numerous examples of thermal cycle fatigue cracking having no interaction with the solder joint void.

- A total of 21 of 40 test vehicles had a void greater than 45% of solder ball diameter or 20% of ball area
- Solder crack path typically found at solder joint / BGA package interface
- Via in Pad (VIP) resulted in significantly more voids in BGA/CSP solder joints than no Via in Pad design
- The voiding percentage in area or diameter of the BGA solder joints did not correlate to the failure cycle in thermal cycling (Figure 7)

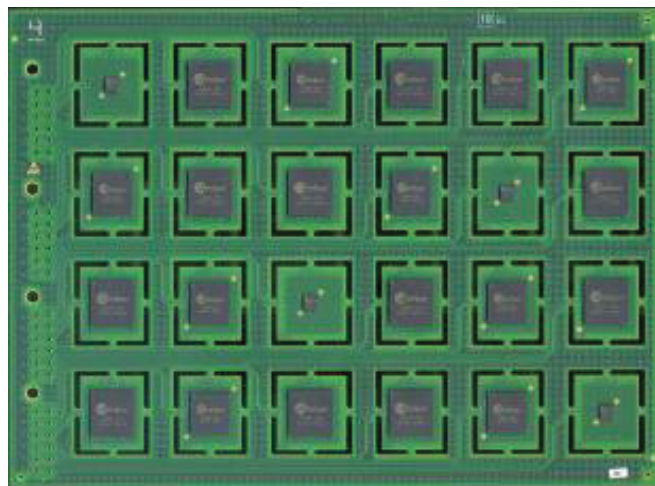
Figure 8. As-Assembled Test Vehicle

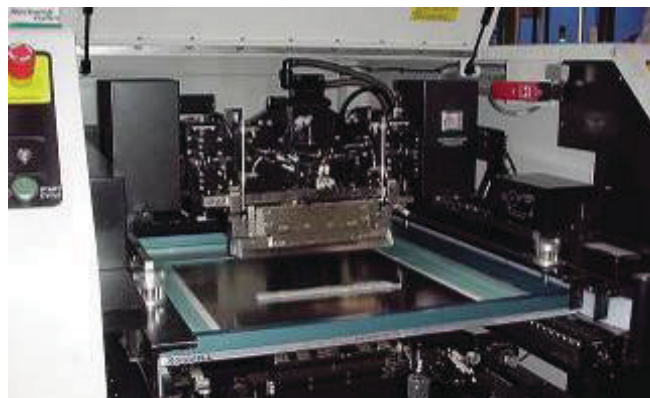
The test vehicles were assembled at the Rockwell Collins Coralville production facility. An MPM Ultra Print 2000 automated stencil printer using a 0.005 inch thick stainless steel stencil applied solder paste to the test vehicles (Figure 9). The solder paste was Alpha tin/lead solder alloy WS-609. The components were placed using the Universal Advantis machine.

Figure 9. MPM Stencil Printer

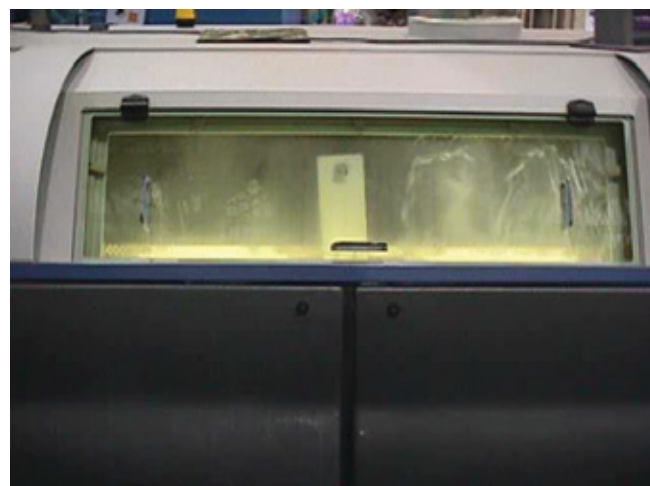
The test vehicles were allowed to air cool after reflow and then placed in the Electrovert Aquastorm 200 in-line cleaning system for removal of solder flux residues and other contaminants from the assembly. The in-line cleaner utilized 13.5% (by volume) Kyzen Aquanox 4625 saponifier in deionized water. The in-line cleaner is shown in Figure 10.

Figure 10. Electrovert Aquastorm In-line Cleaning System

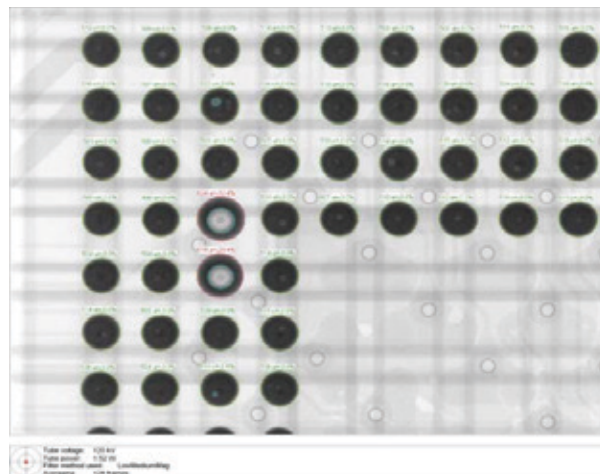
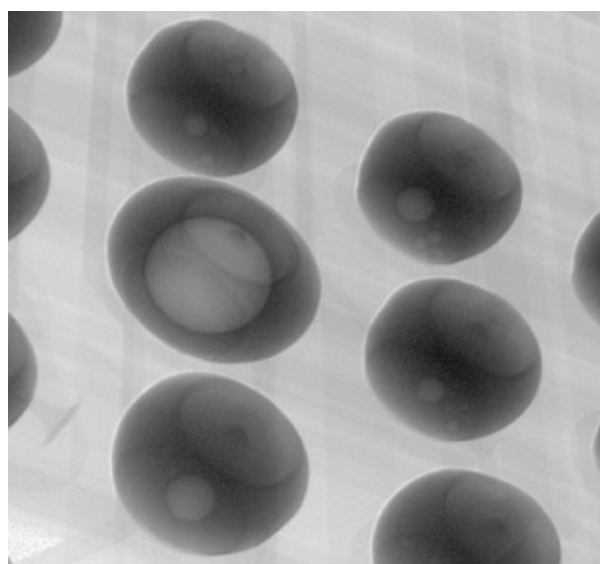
The range of solder voids recorded was from 0% - 35% of X-ray image area, with the majority of the population in the 1% - 10% range. A larger population of solder voids in the 25%-35% range would have been desirable but sufficient solder voids greater than the IPC-JSTD-001 specification of 25% were observed to make the investigation valid. Figure 11 (top) illustrates voids of 32% and 29% area on the inner rows of a test component. Additionally, the low voiding % of the other solder joints is visible. Figure 11 (bottom) shows an oblique view X-ray image of a BGA ball with 30% void. It also shows the interfaces of the solder joint as ellipses above and below the ball.

Figure 11. X-ray Examination of Test Vehicle Revealing: Top
- Voids of 32% and 29% Area, Bottom
- Oblique Angle X-ray View of 30% Void in BGA

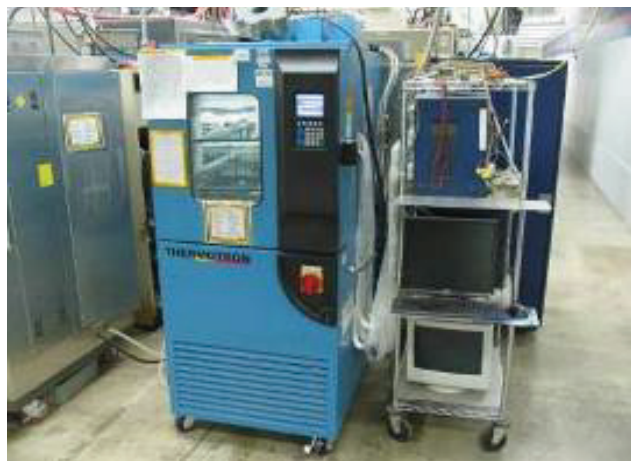
+125°C with a minimum 15 minute dwell at each temperature extreme and a maximum temperature ramp of 10°C/minute. Figure 12 shows the thermal cycling chamber along with the Anatech Event Detection system.

Figure 12. Thermal Cycling Chamber and Anatech

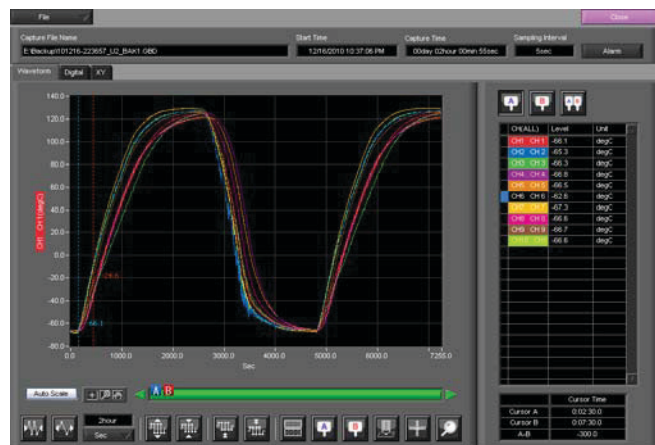
Figure 13 illustrates the thermal profile recorded using the Graphtec Midi Logger GL220 temperature acquisition unit.

Figure 13. Thermal Profile

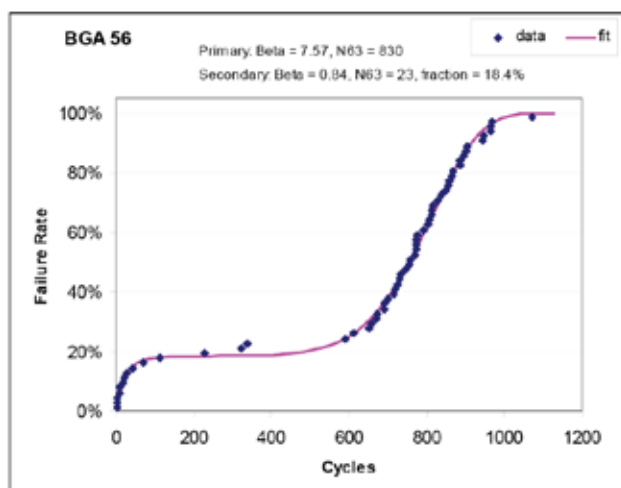
The initial analysis of the data showed that the BGA56 data exhibited characteristics that would be typical of a failure population that contained two distinct failure modes. Figure 14 shows this behavior, in which a number of samples failed prior to 200 cycles, followed by the majority of the population surviving past 600 cycles. A mixed mode Weibull fit was calculated using the equation below. This adds two separate Weibull functions,

Figure 14. Mixed Mode Weibull Fit for BGA56 Data with Voids

Figure 14 showed that the Weibull analysis indicated the existence of two failure modes impacting the BGA56 component solder joint integrity results. Cross-sectional analysis was conducted on the U1 BGA56 component based on the analysis illustrated in Figure 16. The cross-sectional analysis revealed that insufficient solder paste transfer occurred at the U1 component location. The lack of solder paste resulted in the U1 component making an electrical connection with no solder joint structural integrity. The U1 component condition is not a valid solder joint configuration, which justifies its removal from the investigation data set for assignable cause. Figure 29 and Figure 30 illustrate the defective U1 component pad location. The solder joint has a pad impression where it made electrical contact before the thermal cycle induced stresses caused failure.

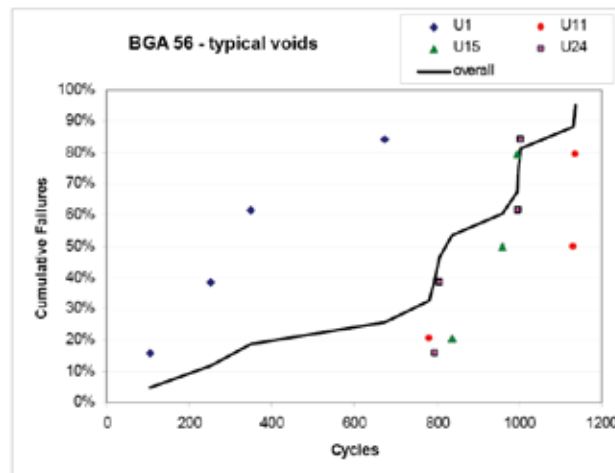
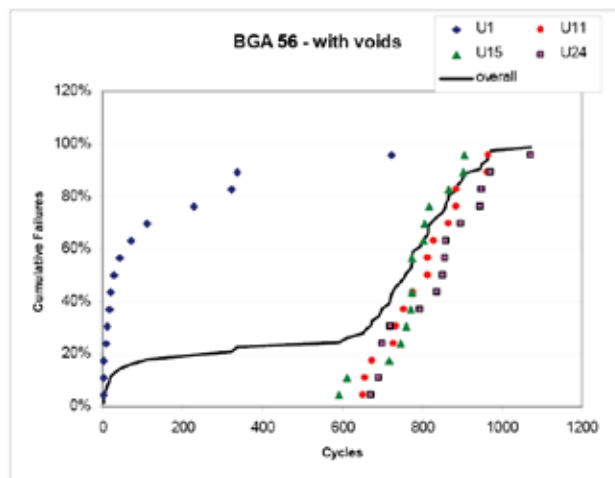
Figure 15 and Figure 16 clearly shows the significant difference in the reliability of the U1 components, which were located in one corner of the test board, compared to the other BGA56 components. This indicated that the secondary failure mechanism was due to an assembly process root cause and not related to the absence or presence of voids in the solder joints. Therefore, subsequent data analysis did not include the data for component reference designator U1.

Figure 15: Failure Distributions for BGA56, by Reference Designator, With Typical Voids

Figure 16. Failure Distributions for BGA56, by Reference Designator, With Voids

For reference, the symbols and colors used in Figure 15 through Figure 18 were defined to help to identify any trends related to the location of a reference designator on the board. Symbols indicate which of the four horizontal rows on the test board that a particular reference designator occupied while the colors correspond to a column. The color/symbol combinations for the reference designator locations are shown Figure 19. There does not appear to be any distinct correlation between the reliability of the components and their location on the test board.

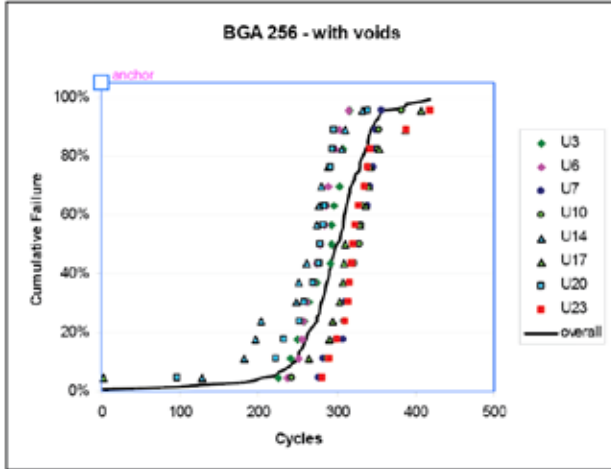
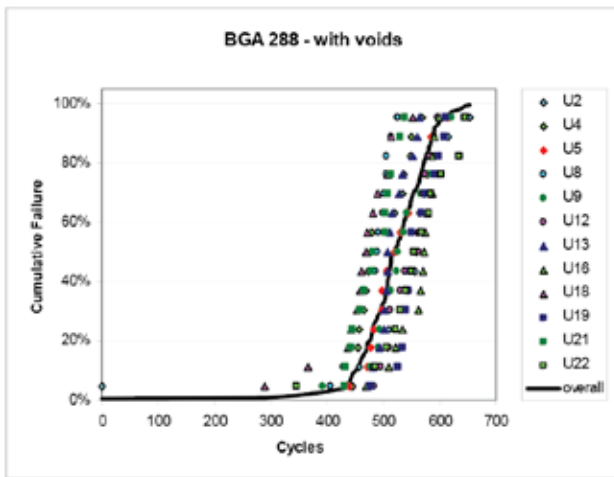
A similar reference designator level analysis was conducted for the BGA256 and BGA288 devices. The results of this analysis, for the samples with voids, are shown in Figure 17 and Figure 18. While these results do show that there was some variation among the individual reliability characteristics depending on the particular reference designator, other than U1 in the BGA56 data set, these differences do not appear to be statistically significant.

Figure 17. Failure Distributions by Reference Designator

Figure 18. Failure Distributions by Reference Designator

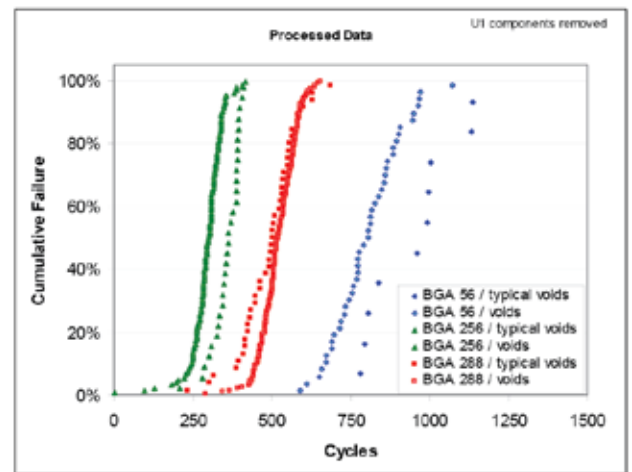
The overall reliability data for the study, not including the data for U1, is shown in Figure 20. This clearly shows that the additional voids have relatively little impact to the overall reliability of the components. The Weibull coefficients calculated for all three components and for typical and voided conditions are shown in Table 4. This table also indicates the impact of the voids on the characteristic life calculated for each data set.

Figure 20. Component Reliability Results

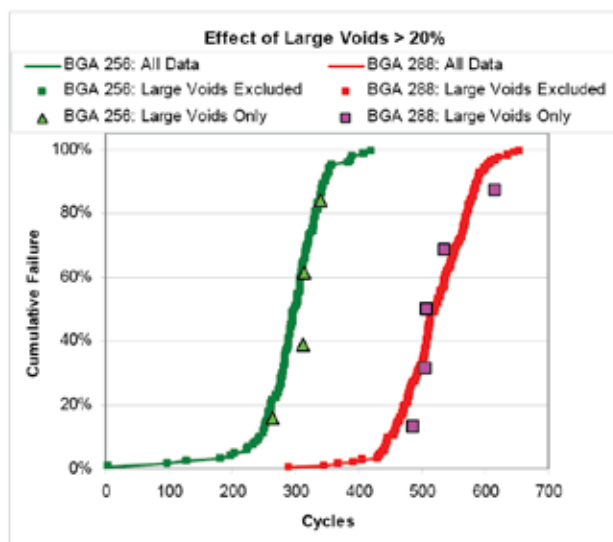
Figure 21. Effect of Large Voids Reliability Results

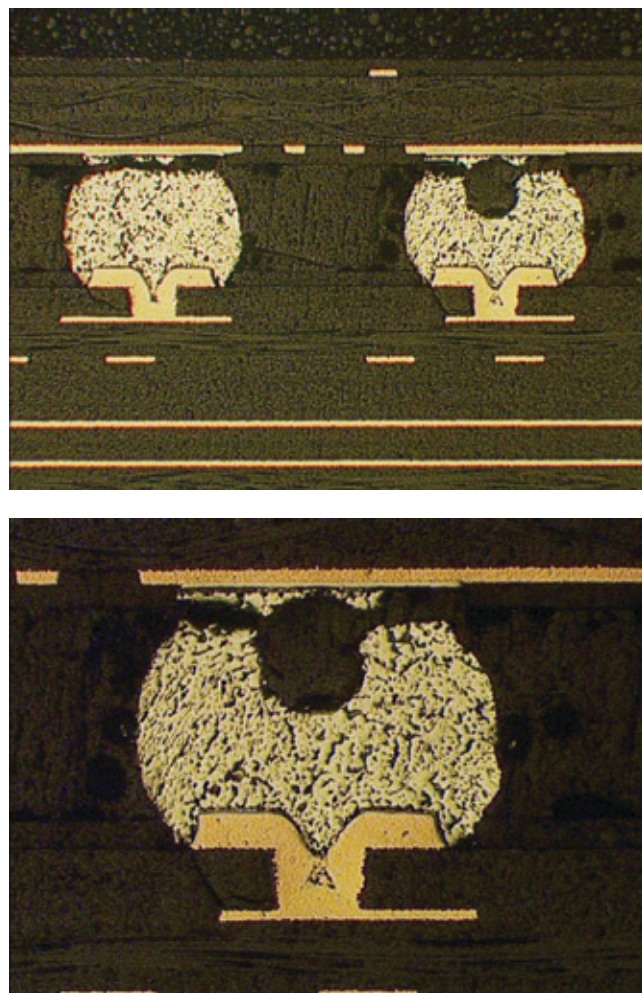
Figure 22 (top image) illustrates two BGA corner/outer row solder joints that failed in the typical location at the component/solder joint interface. One of these solder joints (magnified lower image) has a void less than the 25% maximum requirement but did undergo a loss of solder joint integrity. Figure 23 (top image) illustrates two BGA corner/outer row solder joints that failed in the typical mode but with no voiding present.

Figure 22. Macro (Top) and Magnified (Bottom) Views, BGA Void Assessment: 18% Void, Outer Row, 264 Cycles, BGA256

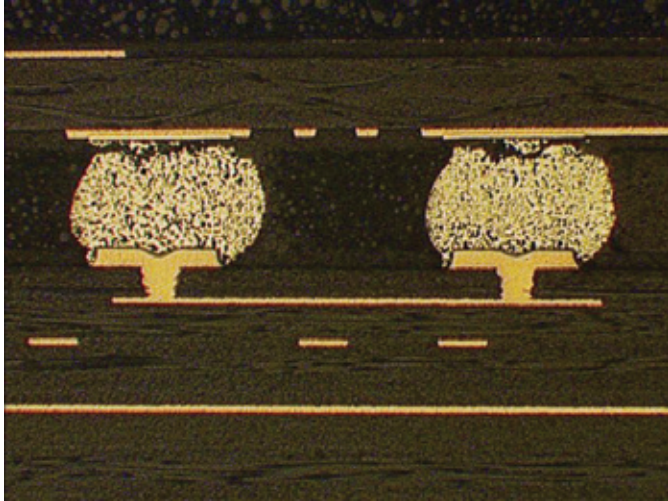
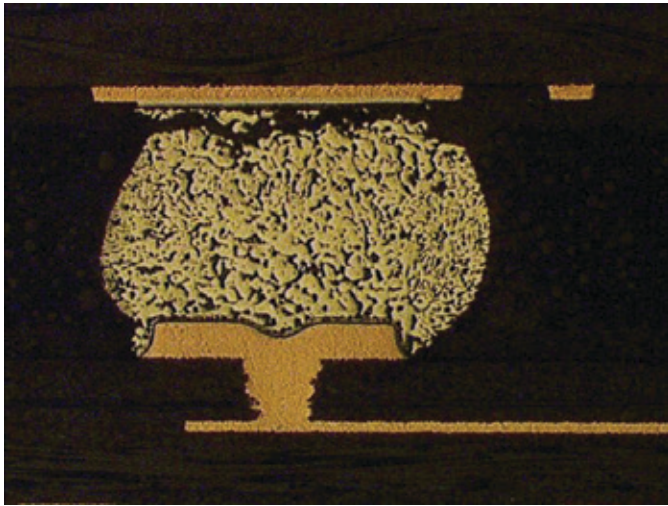
Figure 23. Macro (Top) and Magnified (Bottom) Views BGA Void Assessment: No Void, Outer Row, 311 Cycles, BGA256

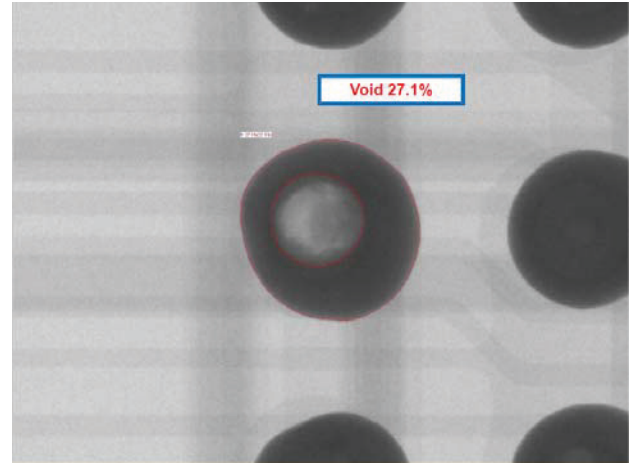
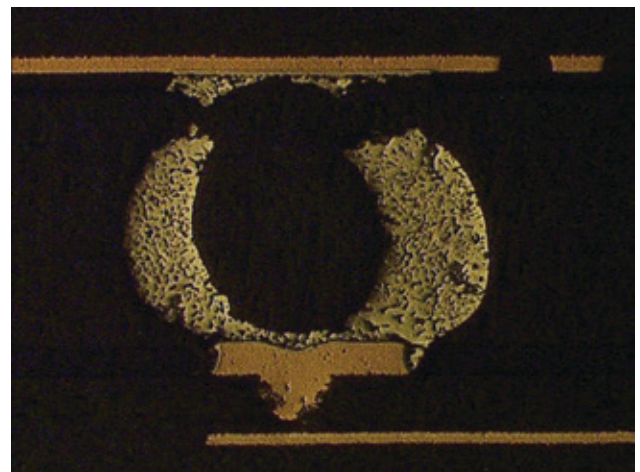
Figure 24 illustrates a solder joint failure due to a 27.1% void that reduced the crack path length and resulted in a loss of solder joint integrity. This BGA solder joint was located on the outer row but not a corner location. Figure 25 and Figure 26 illustrate a solder joint failure due to a 31.3% void reducing the crack path length. This BGA solder joint was located on an inner row/ near package corner location.

Figure 24. X-ray (Top) and Cross Sectional (Bottom) Views BGA Void Assessment: 27.1%, Outer Row, 505 Cycles, BGA 288

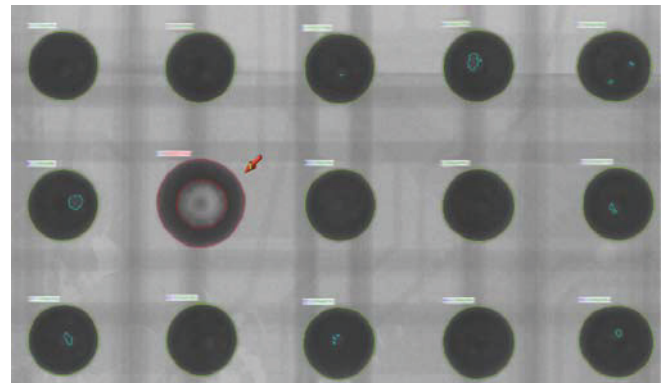
Figure 25. X-ray View, BGA Void Assessment: 31.3%, Inner Row/Corner, 311 Cycles, BGA256

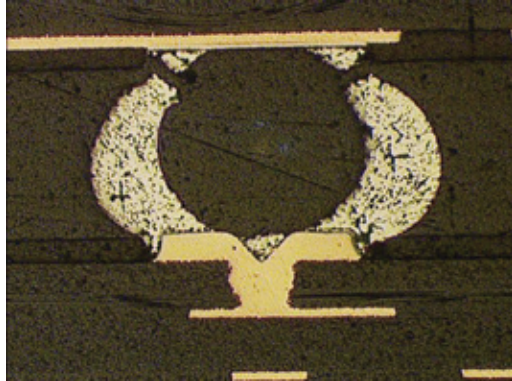
Figure 26. Cross Sectional View, BGA Void Assessment: 31.3%, Inner Row/Corner, 311 Cycles, BGA256

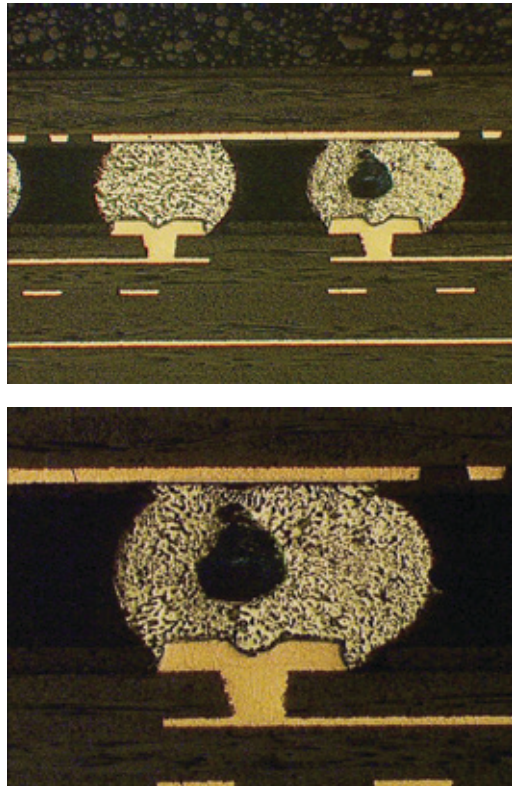
Figure 27 illustrates a typical solder joint containing a 12% void in a BGA solder joint that did not fail the thermal cycling test. This BGA solder joint was located on the outer row but not a corner location. Figure 28 illustrates a typical solder joint containing a 17% void in a BGA inner row that did not fail.

Figure 27. Macro (Top) and Magnified (Bottom) Views, BGA Void Assessment: 12%, Outer Row, No fail, BGA288

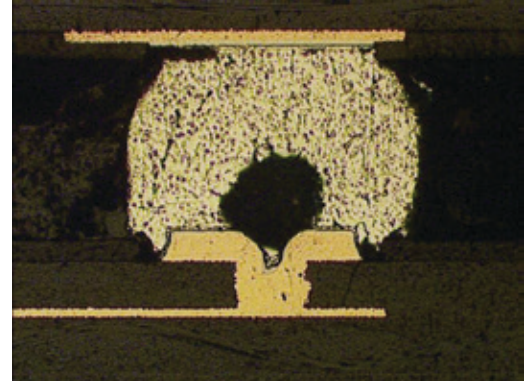
Figure 28. BGA Void Assessment: 17%, Inner Row, No fail, BGA256

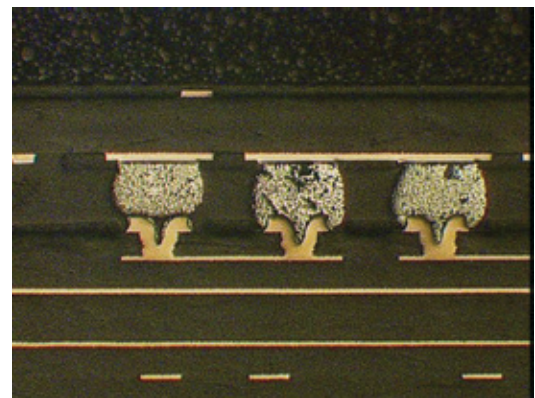
Figure 29. Macro View, BGA56 U1 Component Cross-section Showing Assembly Induced Solder Joint Defect, Failed @ 18 Cycles, BGA 56

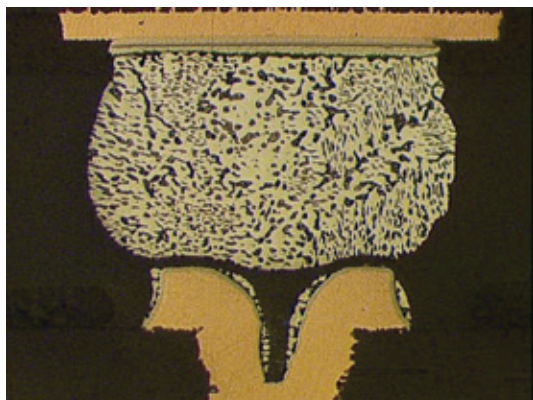
Figure 30. Magnified View, BGA56 U1 Component Cross-section Showing Assembly Induced Solder Joint Defect, Failed @ 18 Cycles, Defect Due to Stencil Paste Deposit Issue, BGA56

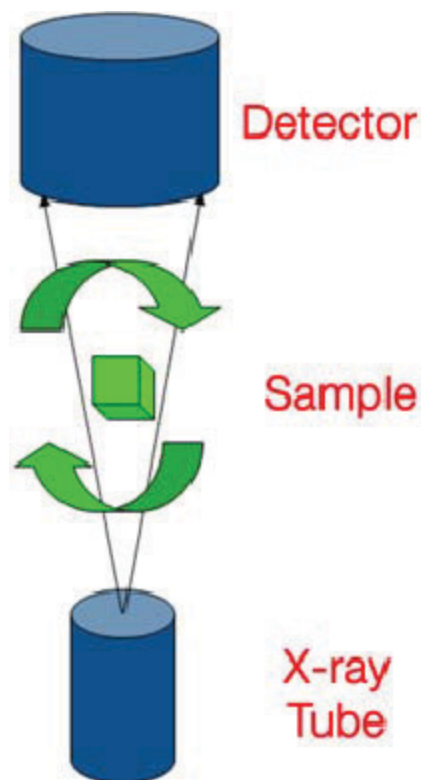
The image acquisition stage of CT may well be the most time consuming phase of the process. It depends on the number of images taken during the sample rotation, as well as the averaging of each image that may be required to improve the signal to noise ratio. The more images that are taken, the more information there is for the CT reconstruction.

Figure 31. Schematic representation of the image acquisition phase of CT inspection

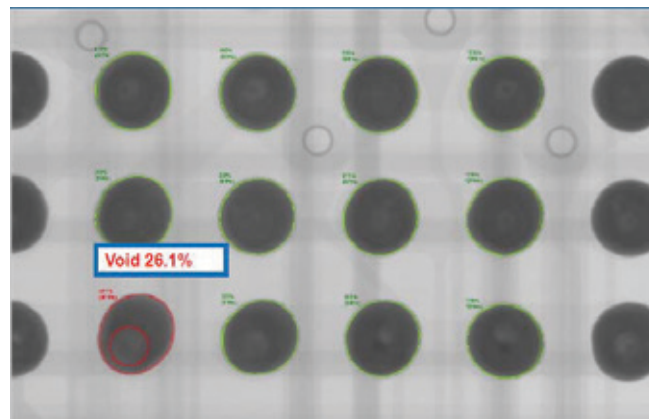
Figure 32 is a 2D X-ray image of the area of interest incorporating void calculations. The location of the voids within the joint is much better assessed using 3D CT virtual cross sectioning. Figure 33 (top) provides a 3D overview of the examined area and Figure 33 (bottom) represents a virtual cross section through the particular BGA row. Black areas represent voids/cracks. The location, size and shape of the voids can be precisely examined. The cracks resulting from the thermal cycling are also clearly visible. Once the CT model is compiled the failure analysis engineer uses dedicated software viewer to pan through each ball in slices as a continuous 'virtual cross-section' through the whole sample in order to evaluate the void size and location. The advantages here compared to mechanical cross-sectioning is that there are no limitations in the position of the virtual section plane, virtual sectioning is fully reversible (as it is done on a software model), and no additional mechanical defects are introduced.

Figure 32. 26.1% BGA Voids Selected for CT Assessment

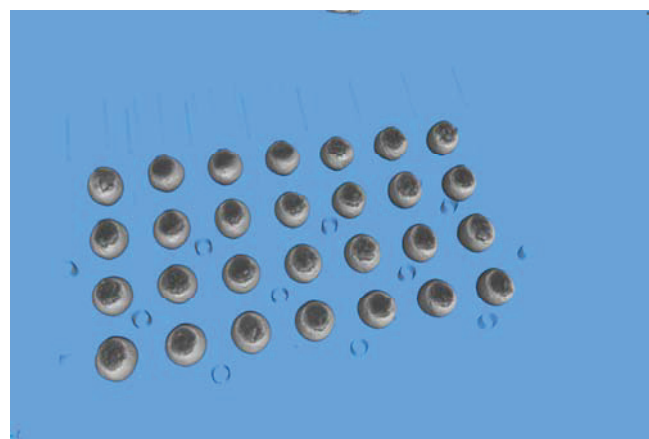
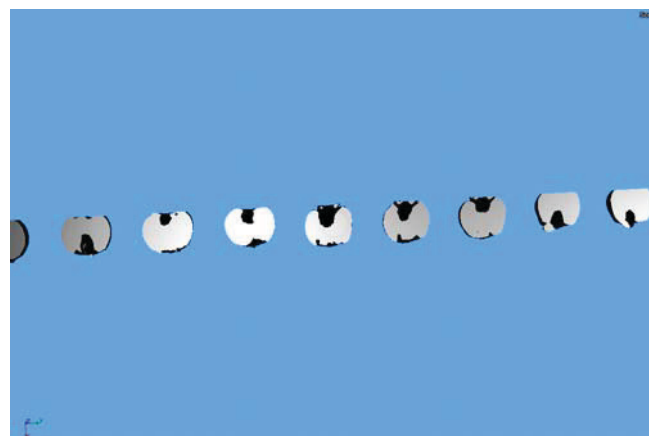
Dr. Evstatin Krastev conducted 3D CT assessment of the BGA voids using the Nordson Dage XD7600NT100 X-ray inspection system after the completion of the thermal cycle testing. The CT assessment allowed for a better understanding of the void location within the solder joints and the interaction of the failure crack path/void interface. The CT assessment results were in agreement with the cross-sectional analysis results indicating that the outer row of the BGA/CSP was most influenced by the void size and location. Figure 32 and Figure 33 illustrate a typical example of the CT assessment of a 26.1% BGA Void on an outer row that failed at 616 thermal cycles.

Figure 33. CT Assessment Image of 26.1% BGA Void. Top - CT overview of examined area, Bottom - CT Virtual cross section revealing voids and cracks represented by black areas.
