# 725D / 725DA Dispense Valve

## Tech Support Guide

## Valve Disassembly

## Valve Maintenance and Reassembly

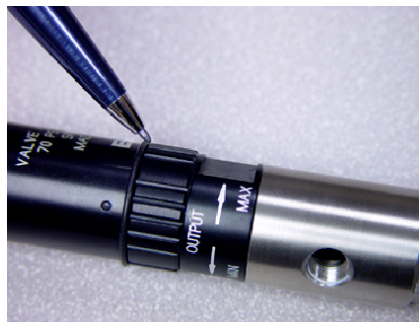
1

1. Turn the stroke adjustment collar to the maximum position.

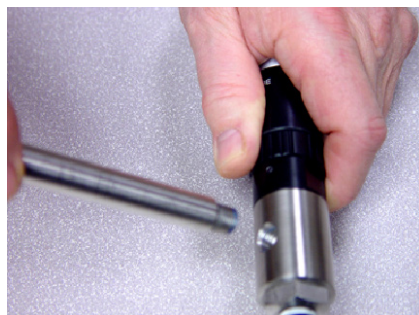
2

2. Install the 1/8 NPT rod in the fluid body mounting hole or fluid inlet.

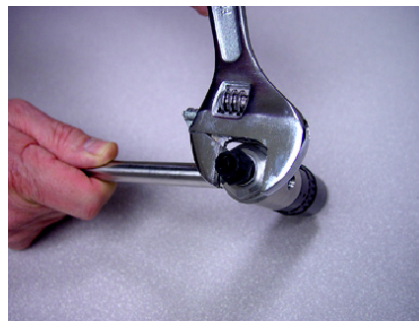
3

3. Holding the rod, use an 8" adjustable wrench to remove the fluid body cap.

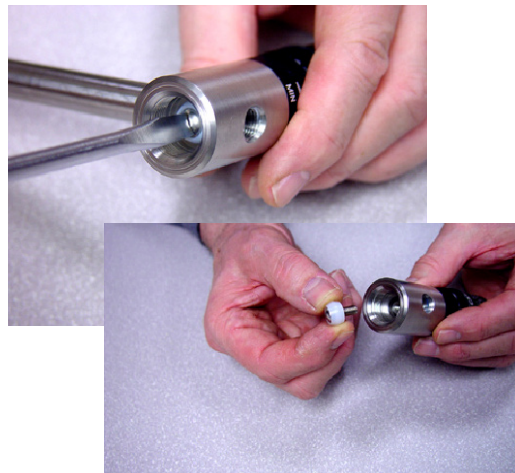
4

4. Using the flat tip screwdriver, remove the sealing head and screw.

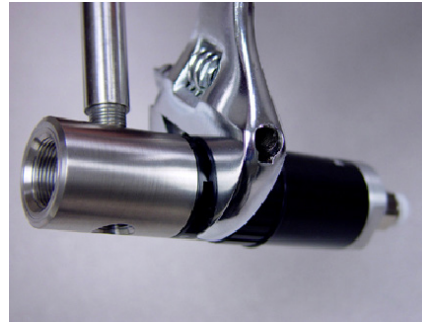
5

5. Holding the rod, use one of the 8" adjustable wrenches to loosen the fluid body.

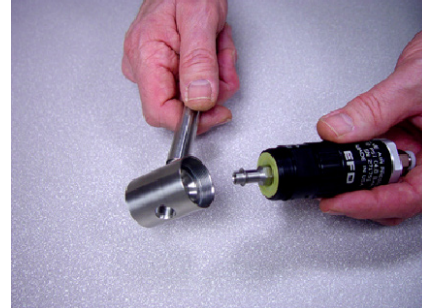
6

6. Remove the fluid body from the air cylinder.

At this point, the fluid end of the valve can be thoroughly cleaned without further disassembly.

For diaphragm replacement or complete valve rebuild, proceed to Step 7.

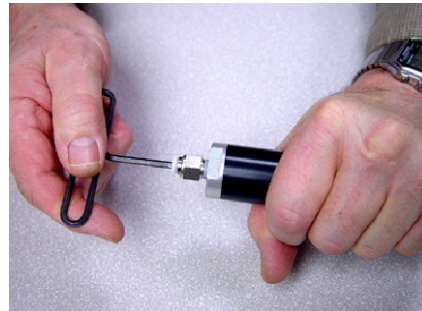
7

7. Insert the 1/8" hex wrench through the air inlet fitting, loosen the shaft locking screw, and turn it out two full turns.

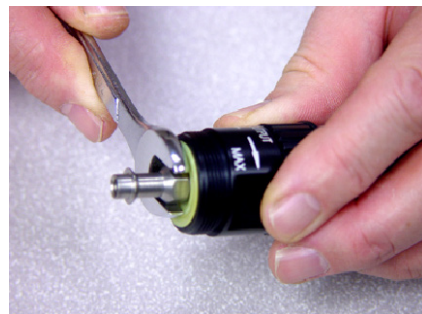
8

8. Using the 3/8" open-end wrench, loosen the shaft.

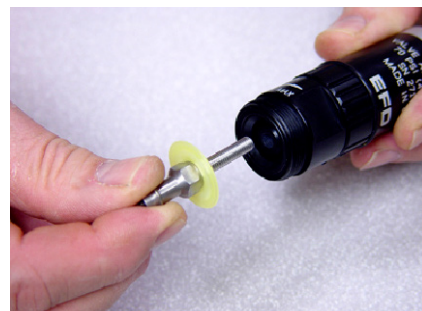
9

9. Remove the shaft and diaphragm.

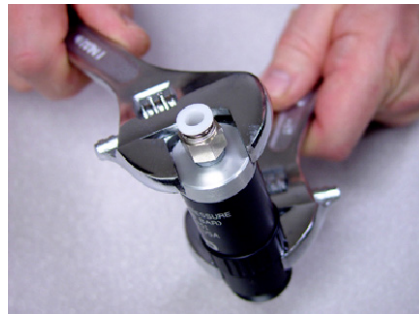
10

10. Place one 8" adjustable wrench on the air cylinder flats and the other 8" adjustable wrench on the cylinder cap flats, and loosen the cylinder cap.

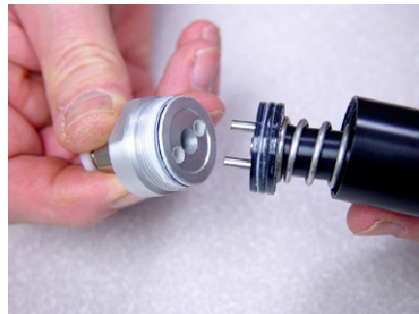
11

11. Remove the cylinder cap, piston and spring from the air cylinder.

The valve is now completely disassembled, and is ready for cleaning, inspection and reassembly.

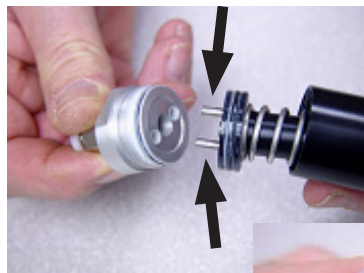
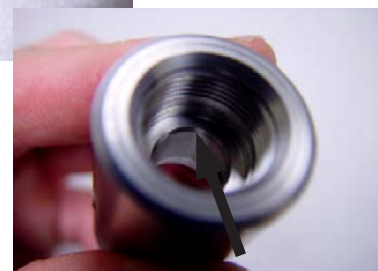
1

- Clean all parts with a solvent that is compatible with the fluid being dispensed.
- Inspect all threads.
- Inspect piston pins for straightness.
- Inspect fluid body seat area for pitting.
- Replace all worn or damaged parts.
- Complete parts lists appear on the last page of these instructions.

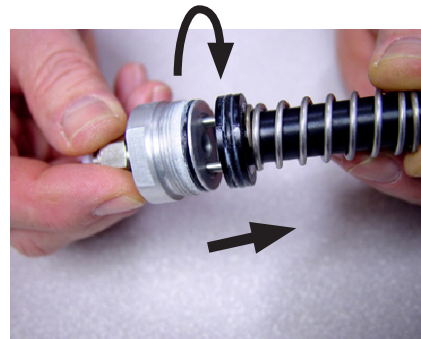
3

3. Assemble the air cylinder cap, piston and spring.

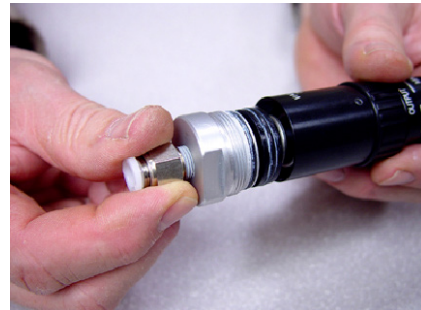
4

4. Install the air cylinder cap, piston and spring by pushing to compress the spring while turning to engage the threads.

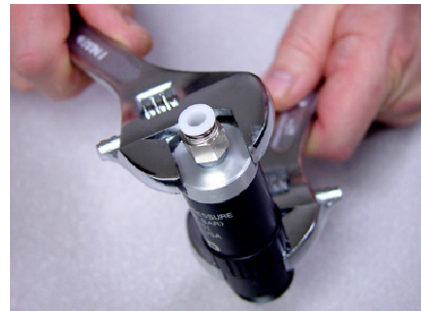
5

5. Using the two 8" adjustable wrenches, tighten the air cylinder cap. If a torque wrench is available, torque to 10.8 Nm (8 ft lbs).

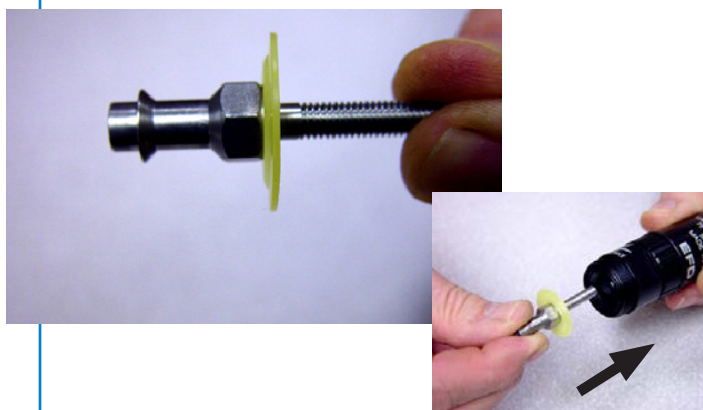
**6**

**6. Install the shaft and diaphragm.**

- The convex ring of the diaphragm should face away from the air cylinder.

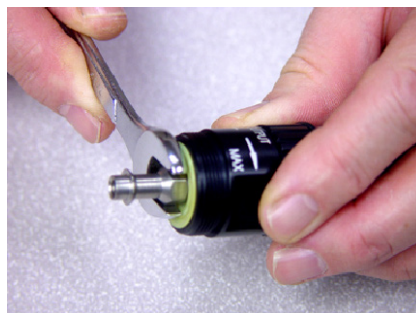
**7**

- 7. Using the 3/8" open-end wrench, tighten the shaft. If a torque wrench is available, torque to 1.69 Nm (15 in lbs).**

**Leaking at vent hole:** Disassemble the valve and review Steps 7–9 to make sure the shaft and fluid body are tight.

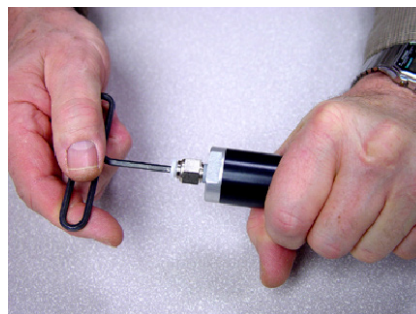
**8**

- 8. Insert the 1/8" hex wrench through the air inlet fitting and tighten the shaft locking screw. If a torque wrench is available, torque to 2.82 Nm (25 in lbs).**

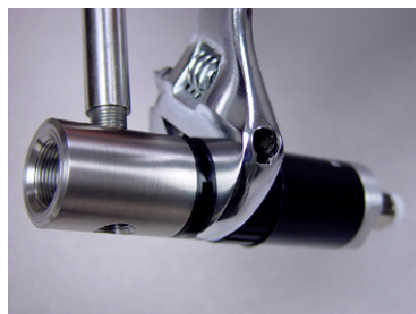
**9**

- 9. Install the fluid body and tighten using the 1/8 NPT rod and 8" adjustable wrench. If a torque wrench is available, torque to 6.78 Nm (5 ft lbs).**

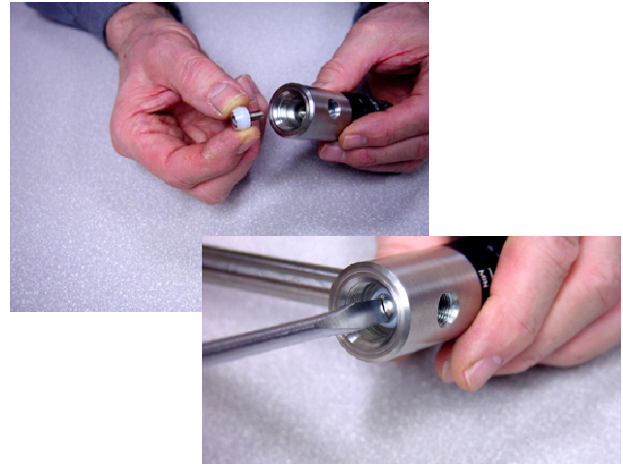
10

10. Install the sealing head and screw using the 1/4" flat tip screwdriver. If a torque screwdriver is available, proper torque is 1.69 nm (15 in lbs).

**Leaking at fluid outlet:** Check the tightness of the sealing head screw. If the screw is tight, remove and check the surface of the fluid chamber seat for pitting. If pitted, replace the fluid body.

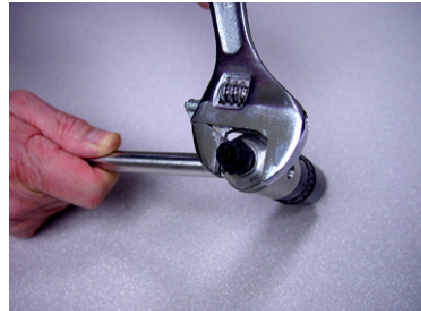
11

11. Install and tighten the fluid body cap using the 1/8 NPT rod and 8" adjustable wrench. Remove the 1/8 NPT rod.

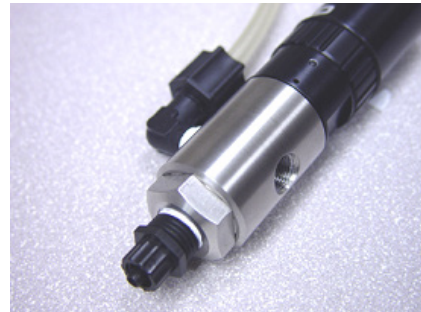
12

12. Pressure test the valve.

- Pressure test the valve by applying 100 psi (7.0 bar) air pressure to the fluid inlet.
- Apply soapy water and check for leaks at the fluid outlet and the small vent hole above the diaphragm.

If the valve leaks after reassembly, proceed as follows:
