Correlating the Presence of Popcorned BGA Devices Post Reflow With Solder-Ball Diameter Measurements From X-Ray Inspection

By David Bernard and Bob Willis

Abstract

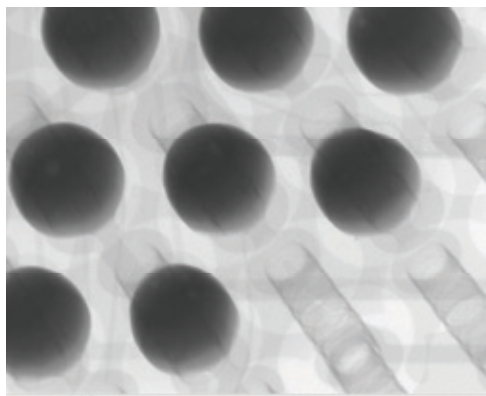
This analysis can be confirmed through an investigation of the solder balls at oblique angle views in the x-ray system. Where there reflow is good then there is a consistency of the solder joints with a typical shape seen in image 3. In contrast, the central solder balls of image 2 when seen at an oblique angle look as shown in image 4. Although there is no bridging in image 2, the difference in solder ball diameter between the inner and outer solder balls is very clear. So this solder ball diameter variation is sufficient to flag this device for at least further investigation, or, more likely, replacement. Therefore measuring and comparing the BGA solder ball diameters offers the opportunity to identify popcorning even if the most obvious signs (bridges) are not present in the x-ray images.

Image 3: Typical x-ray image of good reflowed solder balls under a BGA.
