*Troubleshooting Extrudate Issues:
Orange Peel*

Practical Content Delivered by EDI® Extrusion Die Experts

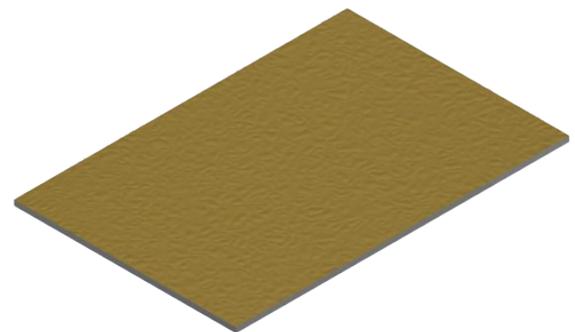
A grainy surface, also known as orange peel, can appear for a variety of reasons. If the melt is too cold, the sheet surface texture may freeze too soon, reducing the overall effectiveness of the polishing rolls.
