752V Series Diaphragm Valve

Maintenance & Parts Guide

Valve Disassembly and Reassembly Procedures

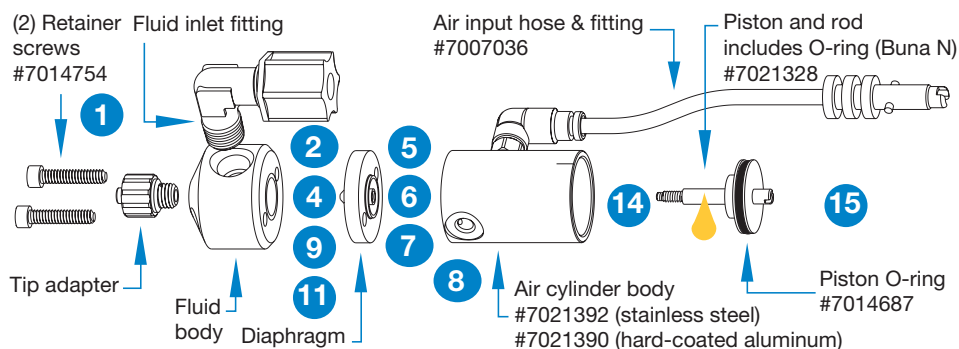
3. Back out stroke control knob two turns counterclockwise from the closed position.
4. Remove fluid body.
5. Unscrew diaphragm (counterclockwise) and remove it from the piston rod.
6. Thread on the new diaphragm and tighten with medium pressure.
7. Align the holes of the diaphragm with the appropriate holes in the air cylinder body by inserting a flat tip screwdriver through the hole in the stroke control knob and engage piston rod slot.
8. Rotate rod, piston and diaphragm assembly clockwise until holes are aligned.
9. Reinstall fluid body.
10. Turn stroke control knob clockwise until closed, and then reopen to desired stroke.

- 11.** Remove fluid body and diaphragm.
- 12.** Remove stroke control knob and spring by turning counterclockwise.
- 13.** Remove the piston retainer ring and anti-torque washer.
- 14.** Remove the piston.
- 15.** Lubricate O-ring, piston shaft and air cylinder wall with Nye Lubricant #865.
- 16.** Reinstall components in reverse order of disassembly.

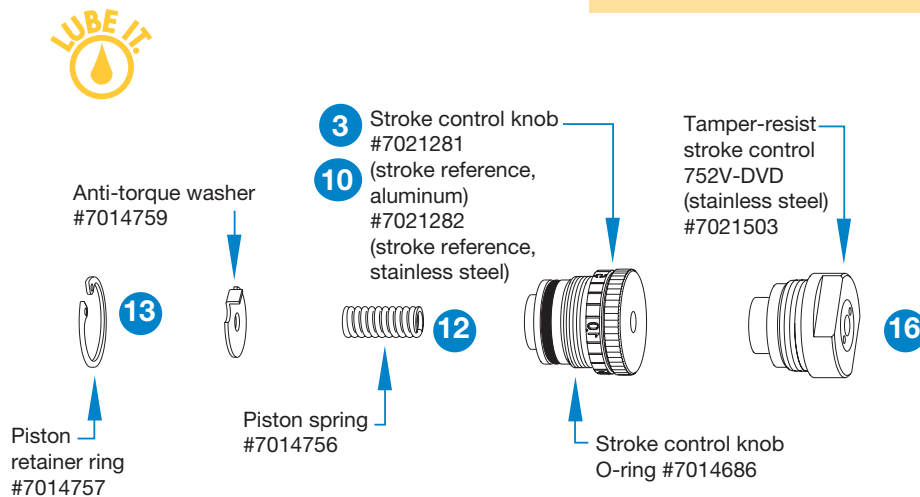
Replacement Parts for Specific Valve Models

Model	Fluid Body			Fluid Inlet Fitting	Diaphragm
	UHMW*	Acetal	Stainless		
752V-SS	n/a	7021356	7021358 [†]	7021499 (1/4" OD tube)	7021287
752V-UHSS	7021360	n/a	7021358	7021499 (1/4" OD tube)	7021287
752V-DVD	n/a	n/a	7021353	7021499 (1/4" OD tube)	7021289
