Use of Digital X-ray Imaging as a Process Control Tool For Lead-Free PWB Assembly

David Bernard, Nick Hoo, and Dominic Lodge

Abstract

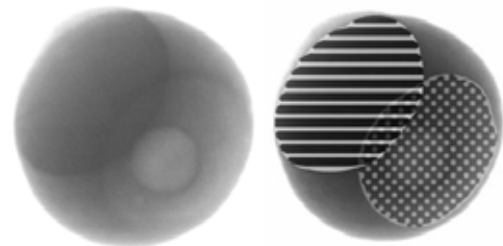
Figure 1: 16-bit digital x-ray image, of a single BGA solder ball at an oblique angle view. The location and size of the interface of the ball to the board, and that of the ball to the device, can be seen as ellipses within the ball. The flattened ellipses have been hand shaded for better clarity. A large void can also be seen with its position clearly adjacent to the lower interface.

An example of where digital x-ray imaging provides a capability for process control that was not possible with analogue x-ray detectors can be seen in figure 1. Here, a single BGA ball is seen at an oblique angle view.

The sensitivity within the system and detector makes it possible to see the shape of the actual joint interfaces, due to the flattening of the solder spheres at the contact surfaces. This creates contrast-resolvable ellipses within the collapsible BGA solder ball. Figure 1 also depicts a large void within the ball. The location of the void adjacent to one of the interface ellipses can be clearly seen in figure 2, where the same BGA ball has been imaged at different oblique views. The presence, or absence, of these ellipses can help to indicate the joint quality, as an absent 'ellipse', compared to neighbouring solder balls within the device, would strongly suggest an open joint.

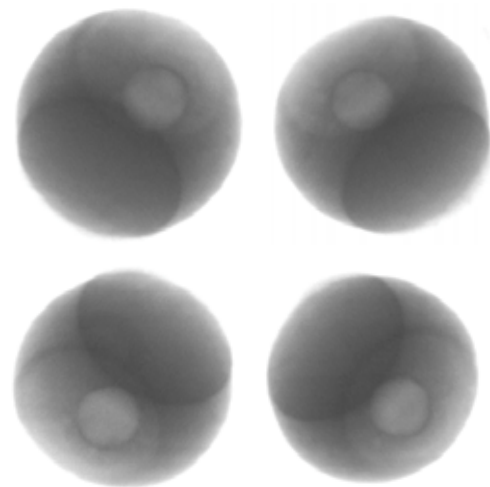
Figure 2: Different oblique-view x-ray images of the BGA ball in figure 1 showing the location of the void relative to the joint interface ellipse.

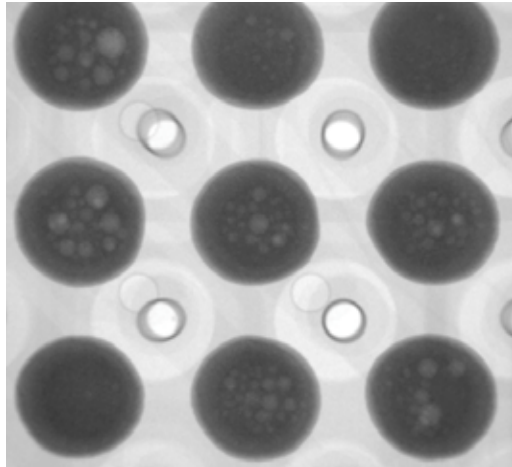
Figure 3: Characteristic digital x-ray image of what is being called 'Champagne Voiding' within BGA joints.

This last problem has been seen only most recently using digital x-ray systems and shows many small voids located within the ball to pad interface. As there are so many voids it has been called 'Champagne Voiding' by some. An example of how this defect looks within an x-ray image is shown in figure 3. The champagne voids are all in the interfacial region, instead of in the bulk of the solder ball, the traditional location of process induced voids. The possible cause of 'champagne voiding' is still

being widely discussed, as it appears on different board finishes with both lead-free and tin-lead solders. Reference 7 contains some further information on this failure mode that, whatever the cause, results in joint failure after accelerated life testing, through repeated thermal cycling. Without the use of digital x-ray imaging and its superior greyscale sensitivity, the small density variation of these tiny voids when x-raying through the whole of the much more dense solder ball would be difficult, if not impossible to resolve.

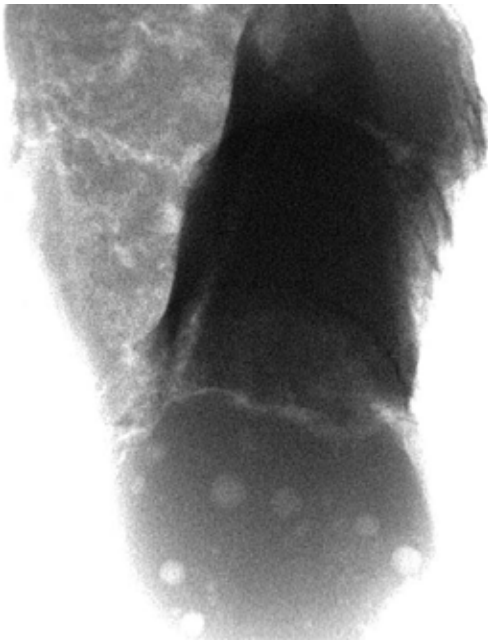
Figure 4: Oblique angle x-ray image of a within a lead-free Leadless Ceramic Chip Carrier (LCCC) joint, soldered to a board, showing a fatigue crack following many repeated thermal cycles.

As digital x-ray inspection offers this enhanced capability across all device joints, it is, therefore, not just limited to BGA and other area array device applications. For example, it can also be used for downstream failure analysis, such as that shown in figure 4. In figure 4, a leadfree LCCC has been thermally cycled many times, which has caused fatigue cracking. Without the additional sensitivity within the digital systems, such results could be missed.

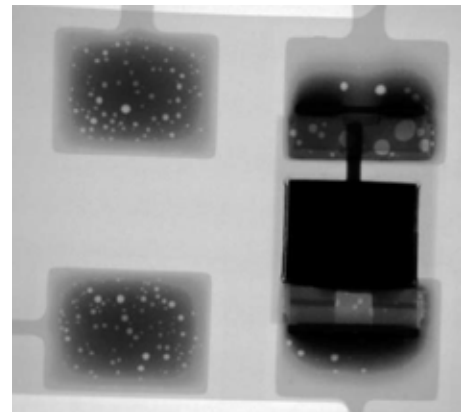
Figure 5: CEM3 board material A with lead-free, SAC alloy, solder paste 3.

it would be assumed that having two different board materials would be the cause of any variation in the voiding levels. However, the results of figures 5, 6 and 7 show the FR4 boards (designated C) and one of the CEM3 board types (designated A) behaved in a similar fashion as each other in terms of voiding. However, the second CEM3 board material (designated B), irrespective of solder alloy used, continually had less voiding than the other two board types. In images 5, 6 and 7 only one type of solder paste (designated 3) is shown for brevity, but the results were consistent across the other two solder pastes. Overall, these images show that the look of solder joints using lead-free materials can be very different from what would have been expected, even when similar board materials are used. As such, it reinforces the need to implement an adequate test and inspection regime so as to confirm and monitor the voiding levels to ensure an optimised production process.

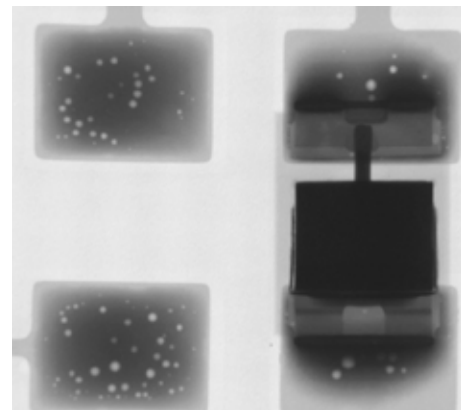
Figure 6: CEM3 board material B with lead-free, SAC alloy, solder paste 3.

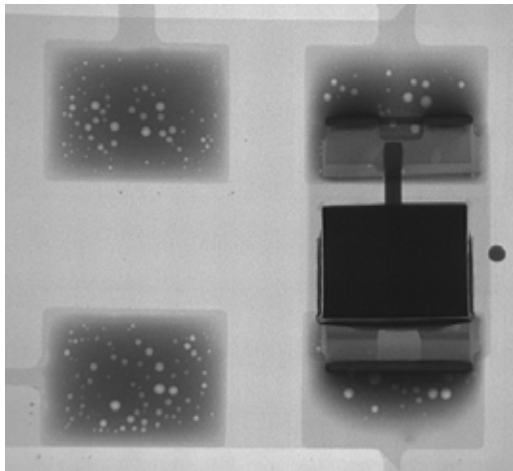
Figure 7: FR4 board material B with lead-free, vSAC alloy, solder paste 3.
