Common Process Defect Identification of QFN Packages Using Optical and X-ray Inspection

By David Bernard and Bob Willis

Abstract

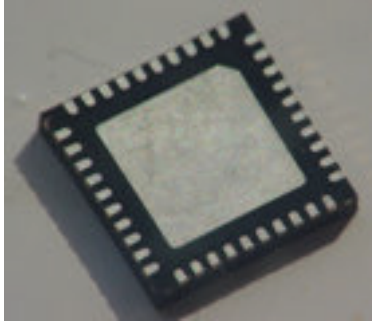
Image 1: Optical image of QFN package terminations

As the package terminations are all located under the device, it makes traditional Automated Optical Inspection (AOI) very difficult, if not impossible, as the main bulk of the edge joints, and the entire central joint, are hidden from view. In addition, should the side terminations on the package not wet during reflow then this will further mitigate the efficiency of AOI with these packages. Manual use of an edge viewing optical microscope does offer some good information as to the quality of the edge joints in these packages, as will be seen later, but, once again, the central joint is unable to be evaluated. In contrast, using x-ray inspection within the production environment offers a non-destructive method for investigating all of the package terminations, including the voiding under the central pad.

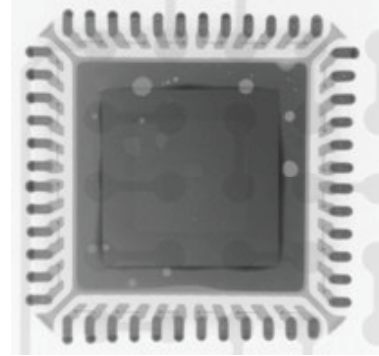
Image 2: X-ray image of QFN post reflow

The use of x-ray inspection for investigating QFN packages has been helped by recent developments made in 2-dimensional (2D) x-ray inspection equipment [1 – 3]. In particular, the improvements in resolution magnification and greyscale sensitivity, especially when inspecting at oblique angle views. In addition, new x-ray systems include digital x-ray imaging detectors, which have enhanced greyscale range as standard, that enables far better visual separation of similarly dense features [3] so as to ensure the best effective identification and analysis (see image 2).

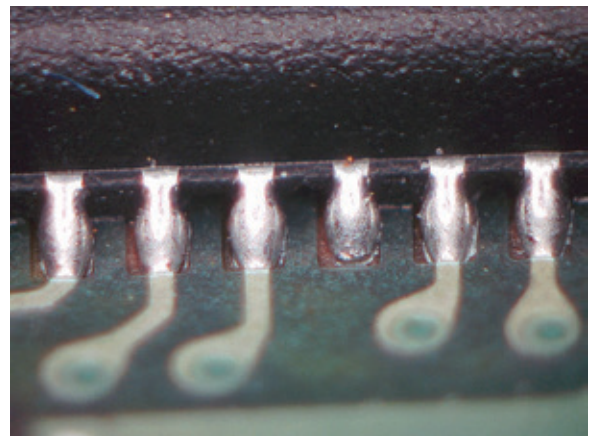
Image 3: Optical image of edge termination solder joints on a QFN component. The component supplier has managed to achieve an optimum plating finish on the terminations which has allowed a 'classically perfect' fillet to form during reflow, which includes coverage of the side terminations.

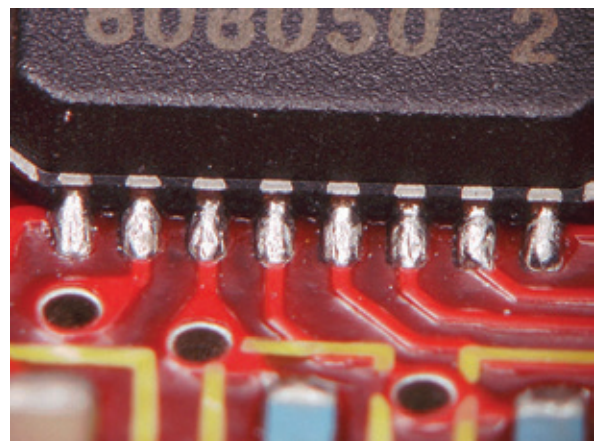
Image 3a: Optical image of edge termination solder joints on a QFN component. This shows satisfactory solder fillets on the edge terminations but there is no substantial wetting of the side terminations. This type of view is far more commonly found during real manufacture.

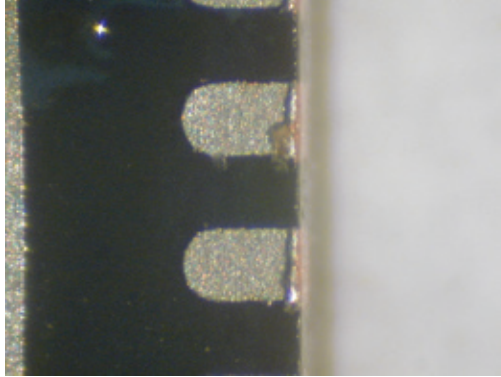
Image 4: Optical image of the base of a QFN showing typical pad burring that may be seen on edge-terminations. This is caused by poor component singulation of the lead-frame during device manufacture.

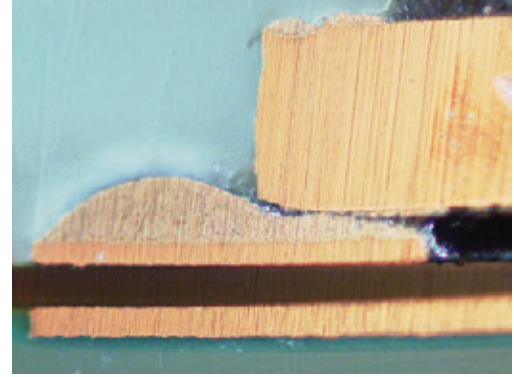
Image 6: Micro-section of a QFN on a flexible circuit. The QFN has 'floated' due to excessive paste deposited on the central pad and/or excessive voiding in the centre pad. This has caused an open joint. This failure may have been exacerbated by solderability or burring issues in the component plating.

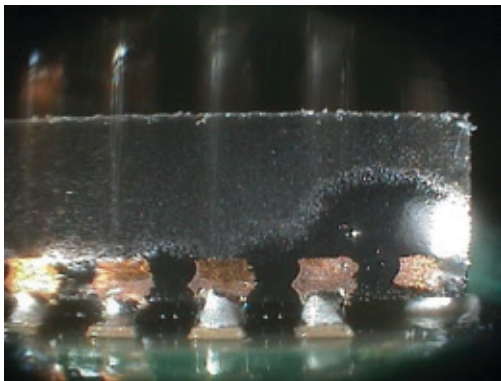
Image 5: Optical image of the edge of a QFN post reflow. The right most joint has not been made successfully and should be compared to the other joints shown. This has been caused by excessive paste being applied to the central QFN pad and/or excessive voiding occurring in the central pad during an inadequate reflow profile. These conditions make the QFN 'float' on the central pad during reflow, which raises the package above the board more than normal, and so interferes with the capillarity action of the reflow process. These issues have also led to variation in the solder quality on the side fillets. Issues with the QFN central pad cannot be seen by visual inspection and it is possible that other factors may also cause failed edge terminations. X-ray inspection (see later) allows a non-destructive view of the central QFN pad to confirm, or otherwise, the analysis.

As described previously (image 5), the most likely cause of this voiding variation is because of solder paste deposition variability during printing owing to the un-optimised nature of the production line used at the 'Experience'. An excess of solder paste may cause the QFN to 'float' over the pad and, as a result, impact on the heat dissipation and/or the efficiency of operation of the package. It should be noted that the excessive voiding levels were slightly more pronounced on convection reflowed boards compared to vapour phase. However, the difference was small and there were many convection reflowed boards that showed little, or no voiding. Any discrepancy in the data may have been caused instead by the wetting efficiency of the PCB solder finish and/or the stencil design.

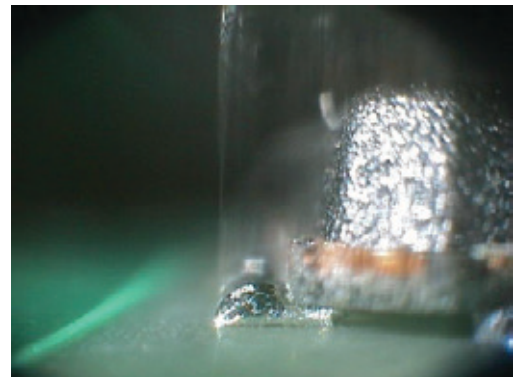
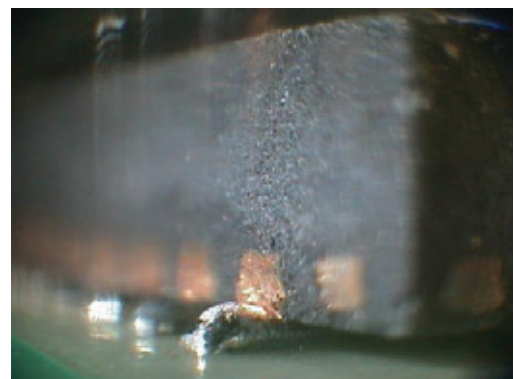
Images 7 & 8: Optical images of a QFN showing that solder joints have formed on the base of the device. However, if the side terminations do not wet then the visual appearance of the joints may vary making it very difficult for AOI inspection. The land pattern should still extend outside of the component footprint and the length of the pad designed under the part should extend to the end of the metalisation. Although good wetting of the side terminations is not required to make a good QFN edge joint, if they are present then it is often a great help to inspecting their quality in the real world of manufacturing.

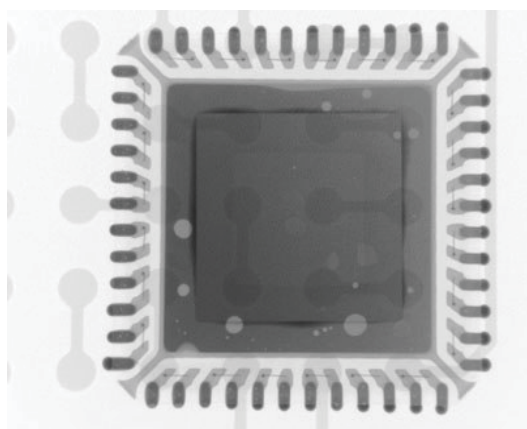
Image 9: X-ray image of a QFN reflowed onto a flexible circuit showing good, consistent edge joints and very little voiding under the central pad.

As with the optical inspection images, the test boards have provided useful reference x-ray images to show the difference between good and bad QFN joints (see images 9 and 10). The defects were more likely caused by the rush to produce boards from an ad hoc assembly line at an exhibition rather than by any underlying issues with the use of QFN packages under convection or vapour phase reflow. The good joints remained good, even after the thermal cycling.

It was in the central pad however, clearly seen under x-ray inspection, where the voiding levels varied dramatically across all the test boards. This was irrespective of the reflow method used on the board and this variation was especially marked on the QFNs placed on the flexible circuits (see images 9 and 10).

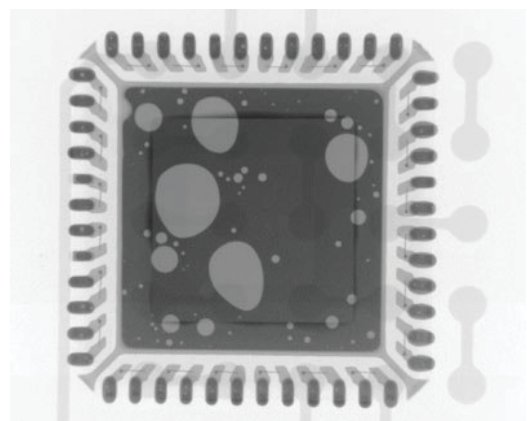
Image 10: X-ray image of a QFN reflowed onto a flexible circuit showing open edge joints (as seen by the shape of, and less material in, the joint – see arrows and compare with image 9 and the substantial voiding under the central pad).

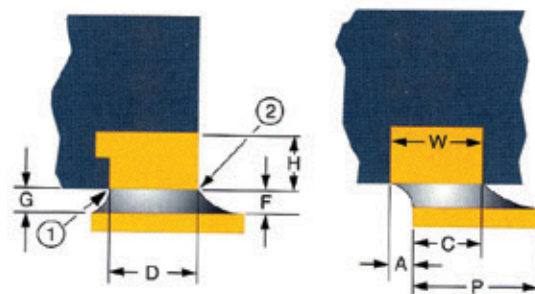
Diagram 1: Optical inspection criteria for QFNs (from IPC-A-610D – see reference 6).

Optical inspection criteria for QFNs are suggested by the IPC-A-610D document [6]. In particular, it suggests that the maximum side overhang of the termination relative to the pad be at most 25% of the pad width for class 2 and 3 products. It also suggests that the minimum end joint width is at least 75% of the total pad width for class 2 and 3 products (see diagram 1).

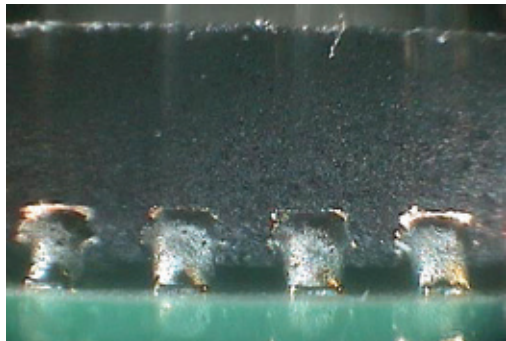
Image 11: Optical image of acceptable QFN edge terminations. Solder fillets should exist if the design incorporates pads that extend beyond the package width.

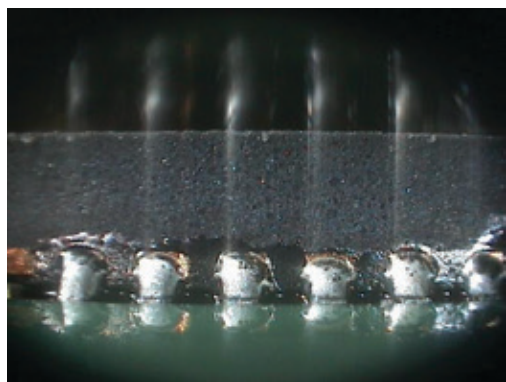
Image 12: Optical image of acceptable QFN edge terminations. Solder fillets should be visible to a minimum of 75% of the width of the termination.

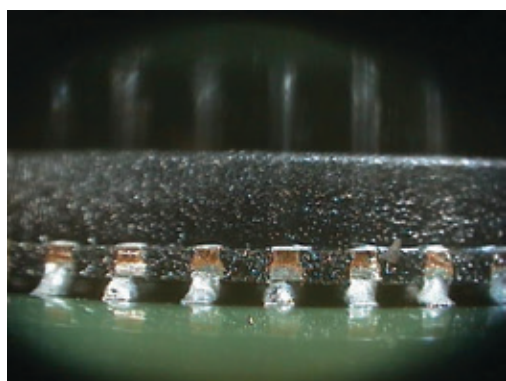
Image 13: Optical image of unacceptable QFN edge terminations. The solder rise is limited and an open joint can be seen. The package is also 'floating' above the surface of the pads.

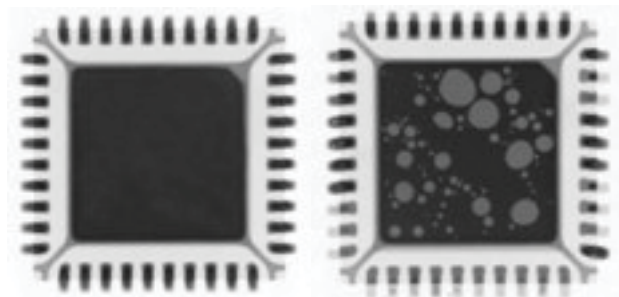
Image 14: X-ray images of QFNs following reflow showing an ideal example (left) and an unsatisfactory one. Note the joint variations in the unsatisfactory example which can be clearly seen, even at low magnification, and therefore, with this x-ray system, does not require additional higher magnification or oblique angle views to be taken.

As there is no explicit recommendation in the IPC-A-610D as to acceptable x-ray inspection criteria for QFNs, the following are suggested as a guideline. Further information on suggested x-ray inspection guidelines for a range of typical components used in production can be seen in reference 8. A comparison between x-ray images of a good and a bad QFN are shown in images 9 and 10 as well as in image 14.

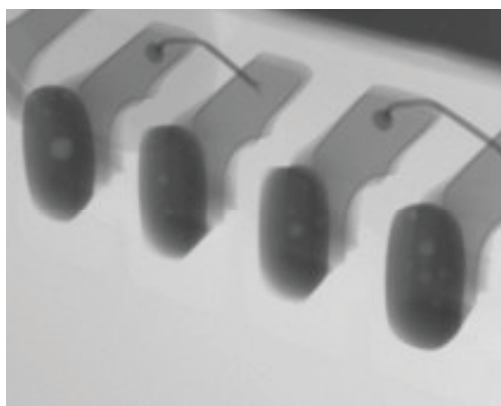
Image 15: Target Condition of QFN edge joints where showing a moderate level of voiding within joints is acceptable. All joints have reflowed.

Images 15 – 17 and 18 – 20 show three example x-ray images of QFNs. Each indicates a different level of joint condition acceptability for the edge and central terminations respectively.

1. Target Condition – An image of the ideal solder joint when inspected with x-ray.
2. Acceptable Condition – An image of the joint appearance in the x-ray system that is at the maximum permitted level of deviation from that set as the target condition. These joints will not require rework but suggest a process review be considered to improve the joint quality towards the target condition. This level is the minimum condition for the production process.

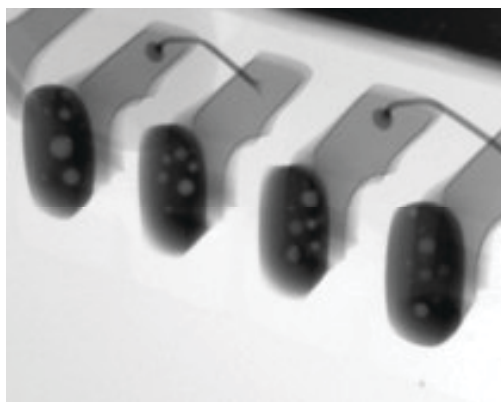
Image 16: Acceptable Condition of QFN edge joints showing an increased level of voiding within the joints but well within any action level.

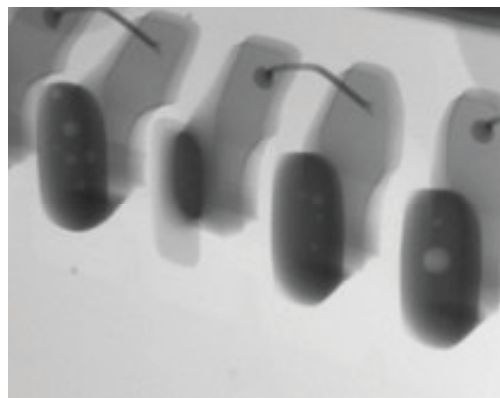
Image 17: Defect Condition of QFN edge joints showing insufficient solder in a joint (this example) or voiding exceeds 20% of the joint area of a single joint.

3. Defect Condition – An image of the joint appearance in the x-ray system indicating an unacceptable joint. The cause(s) of this condition should be investigated and necessary corrective action to the process applied. Possible rework of such joint conditions should wait until the process has been corrected.

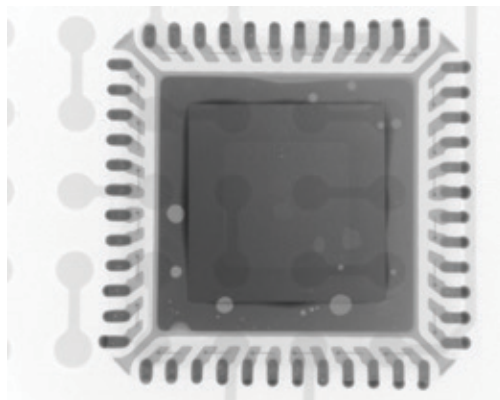
Image 18: Target Condition - Moderate level of voiding under the central termination is acceptable. All edge terminations are consistent.

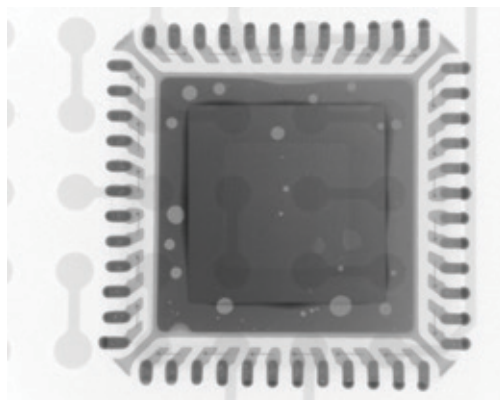
Image 19: Acceptable Condition – An increased level of voiding is seen in the central termination.

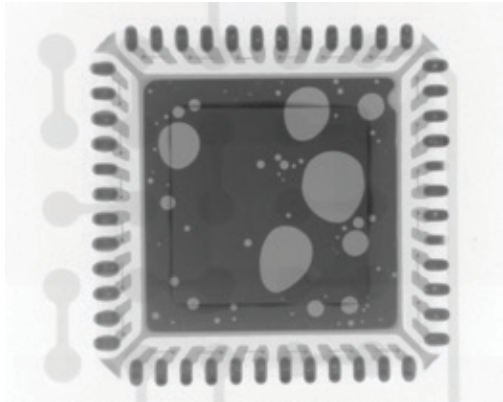
Image 20: Defect Condition - Excessive level of voiding is seen both in total quantity and for individual voids. Open joints are also seen in the edge terminations.
